ISSAQUEENA LOOKOUT TOWER – RESTORATION COMMITTEE REPORT

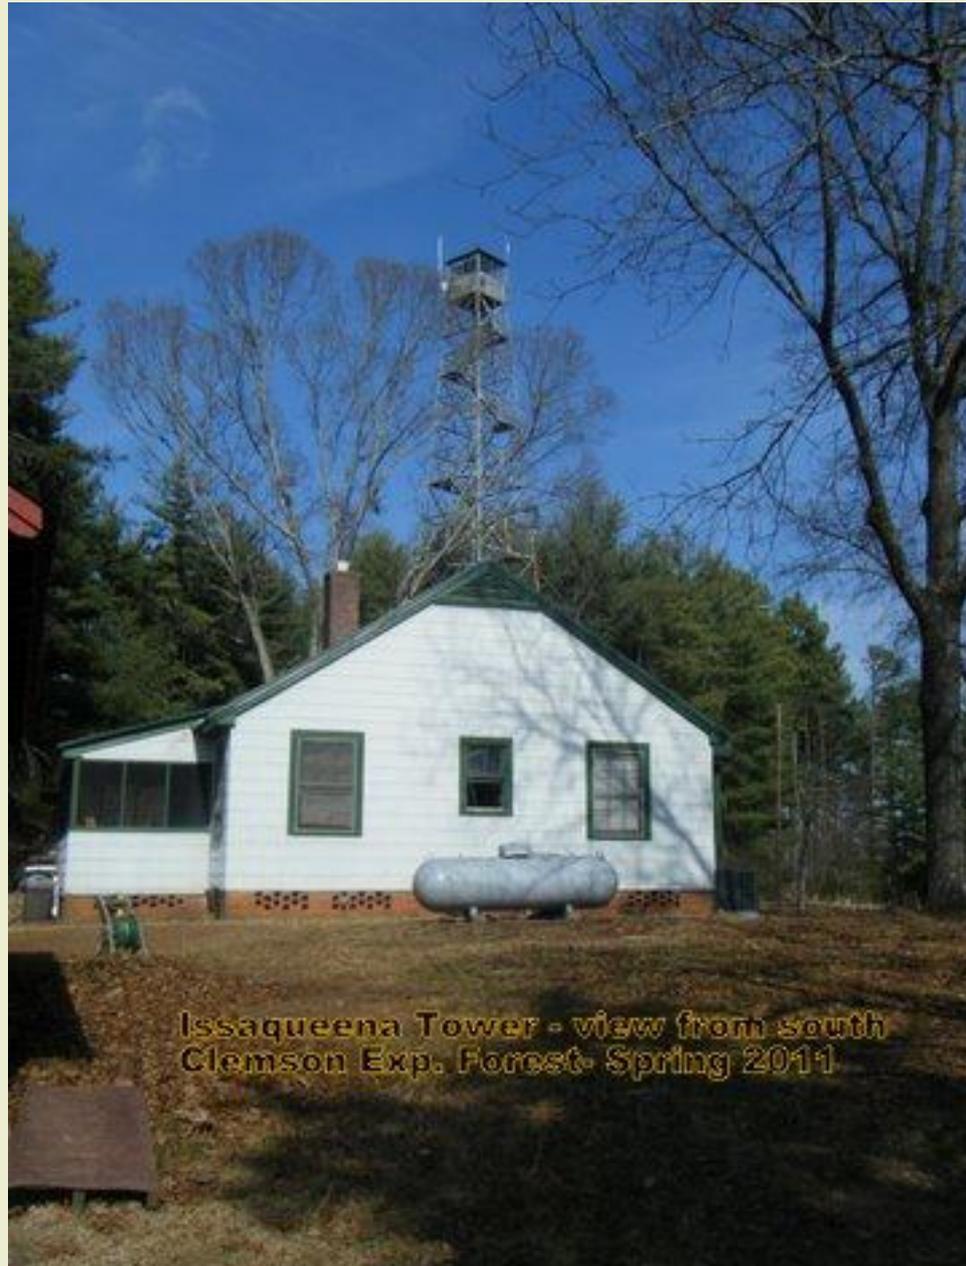
Issaqueena Lookout Tower House & Buildings, ca. 1938
Clemson Exp. Forest

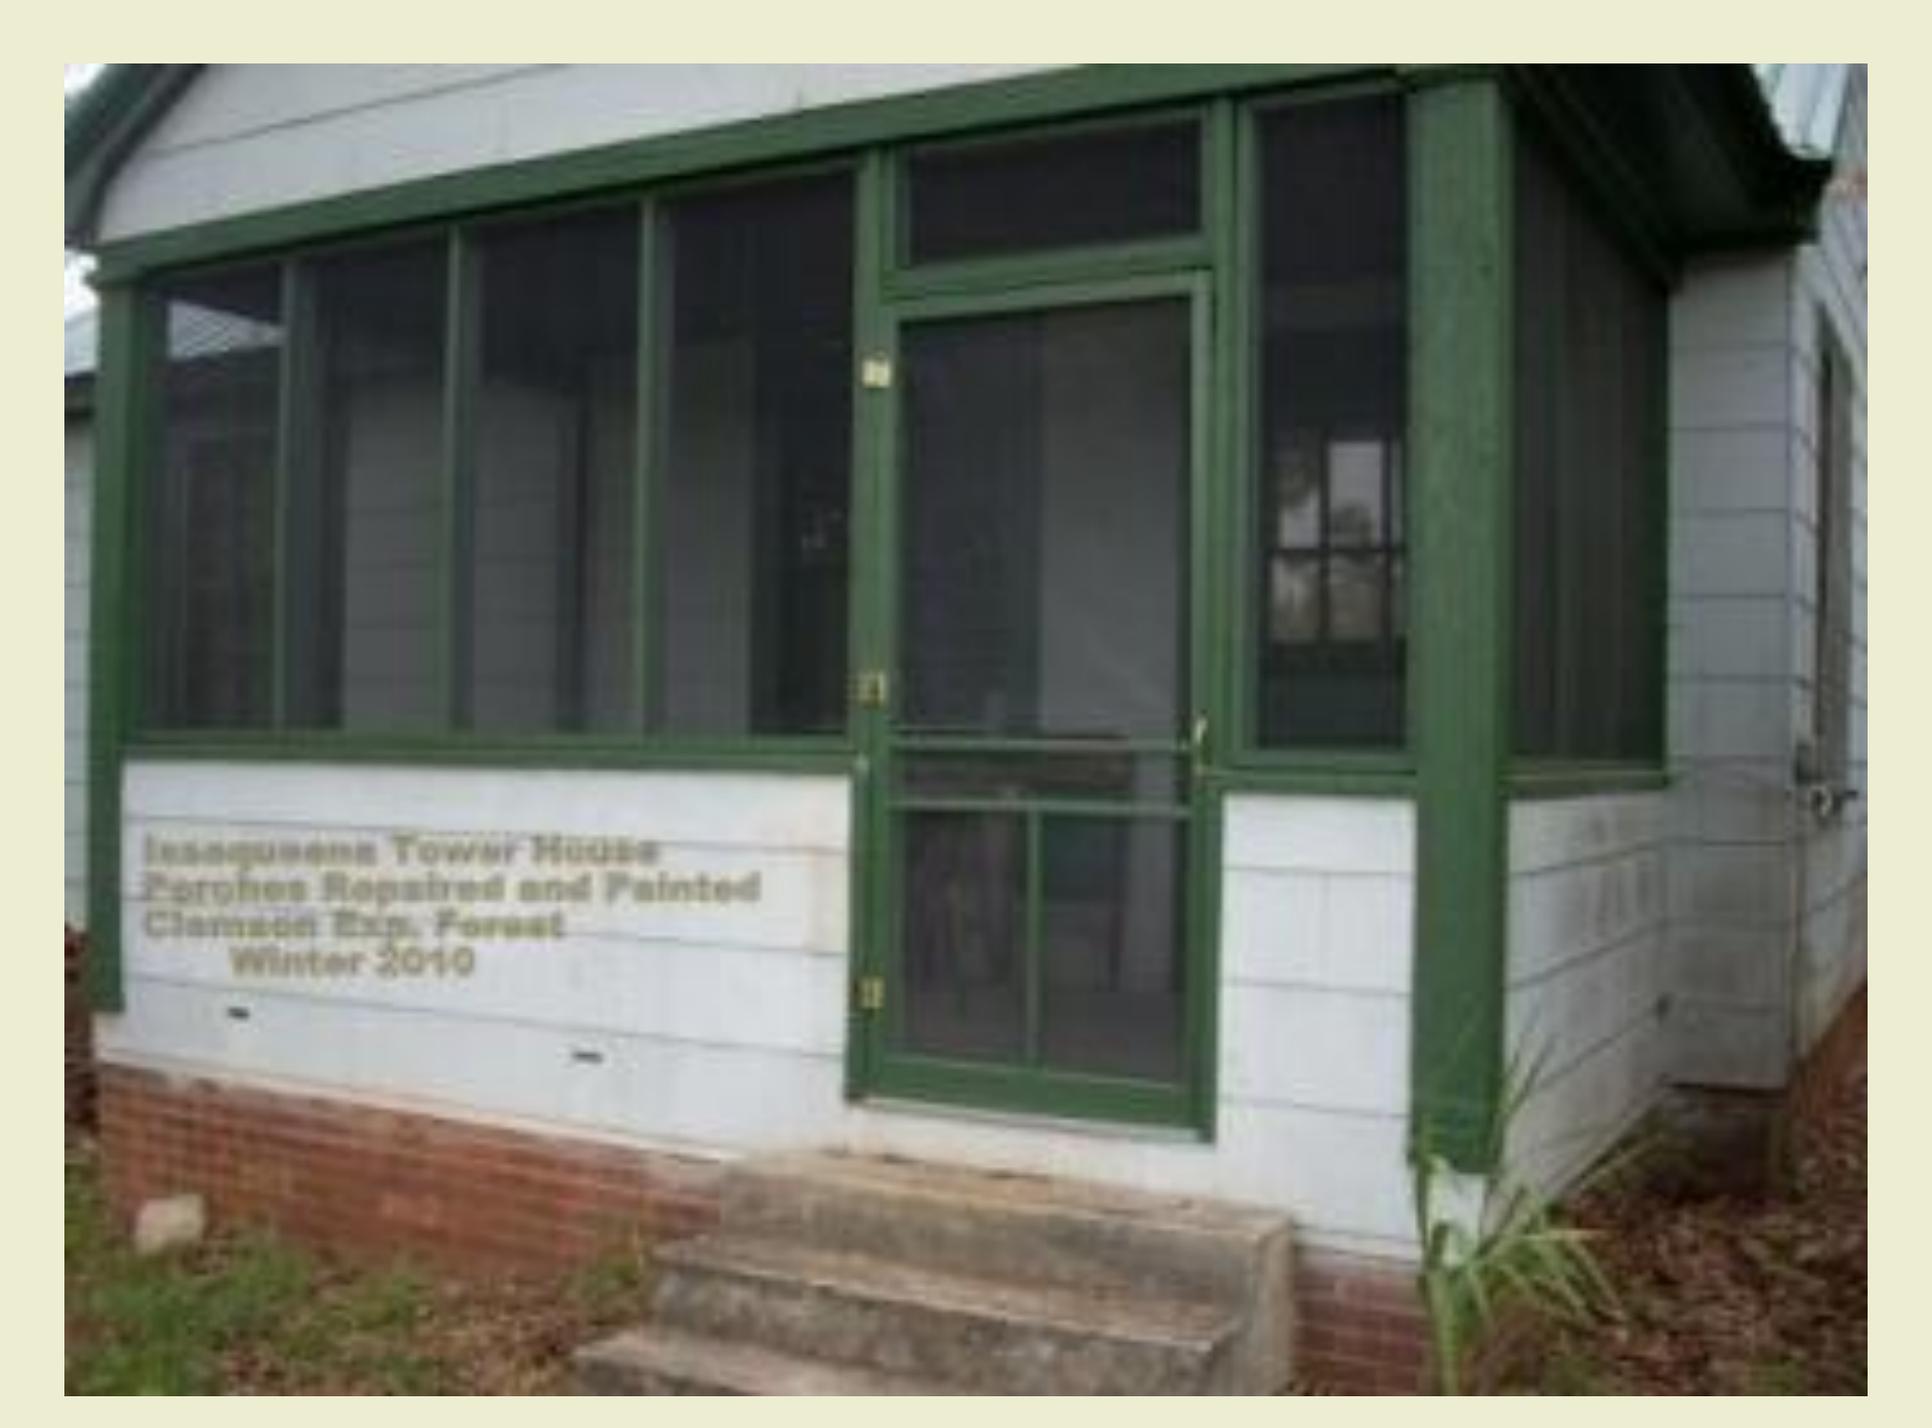
Isaqueena Tower House
Porches Repaired and Painted
Clamaco Exp. Forest
Winter 2010

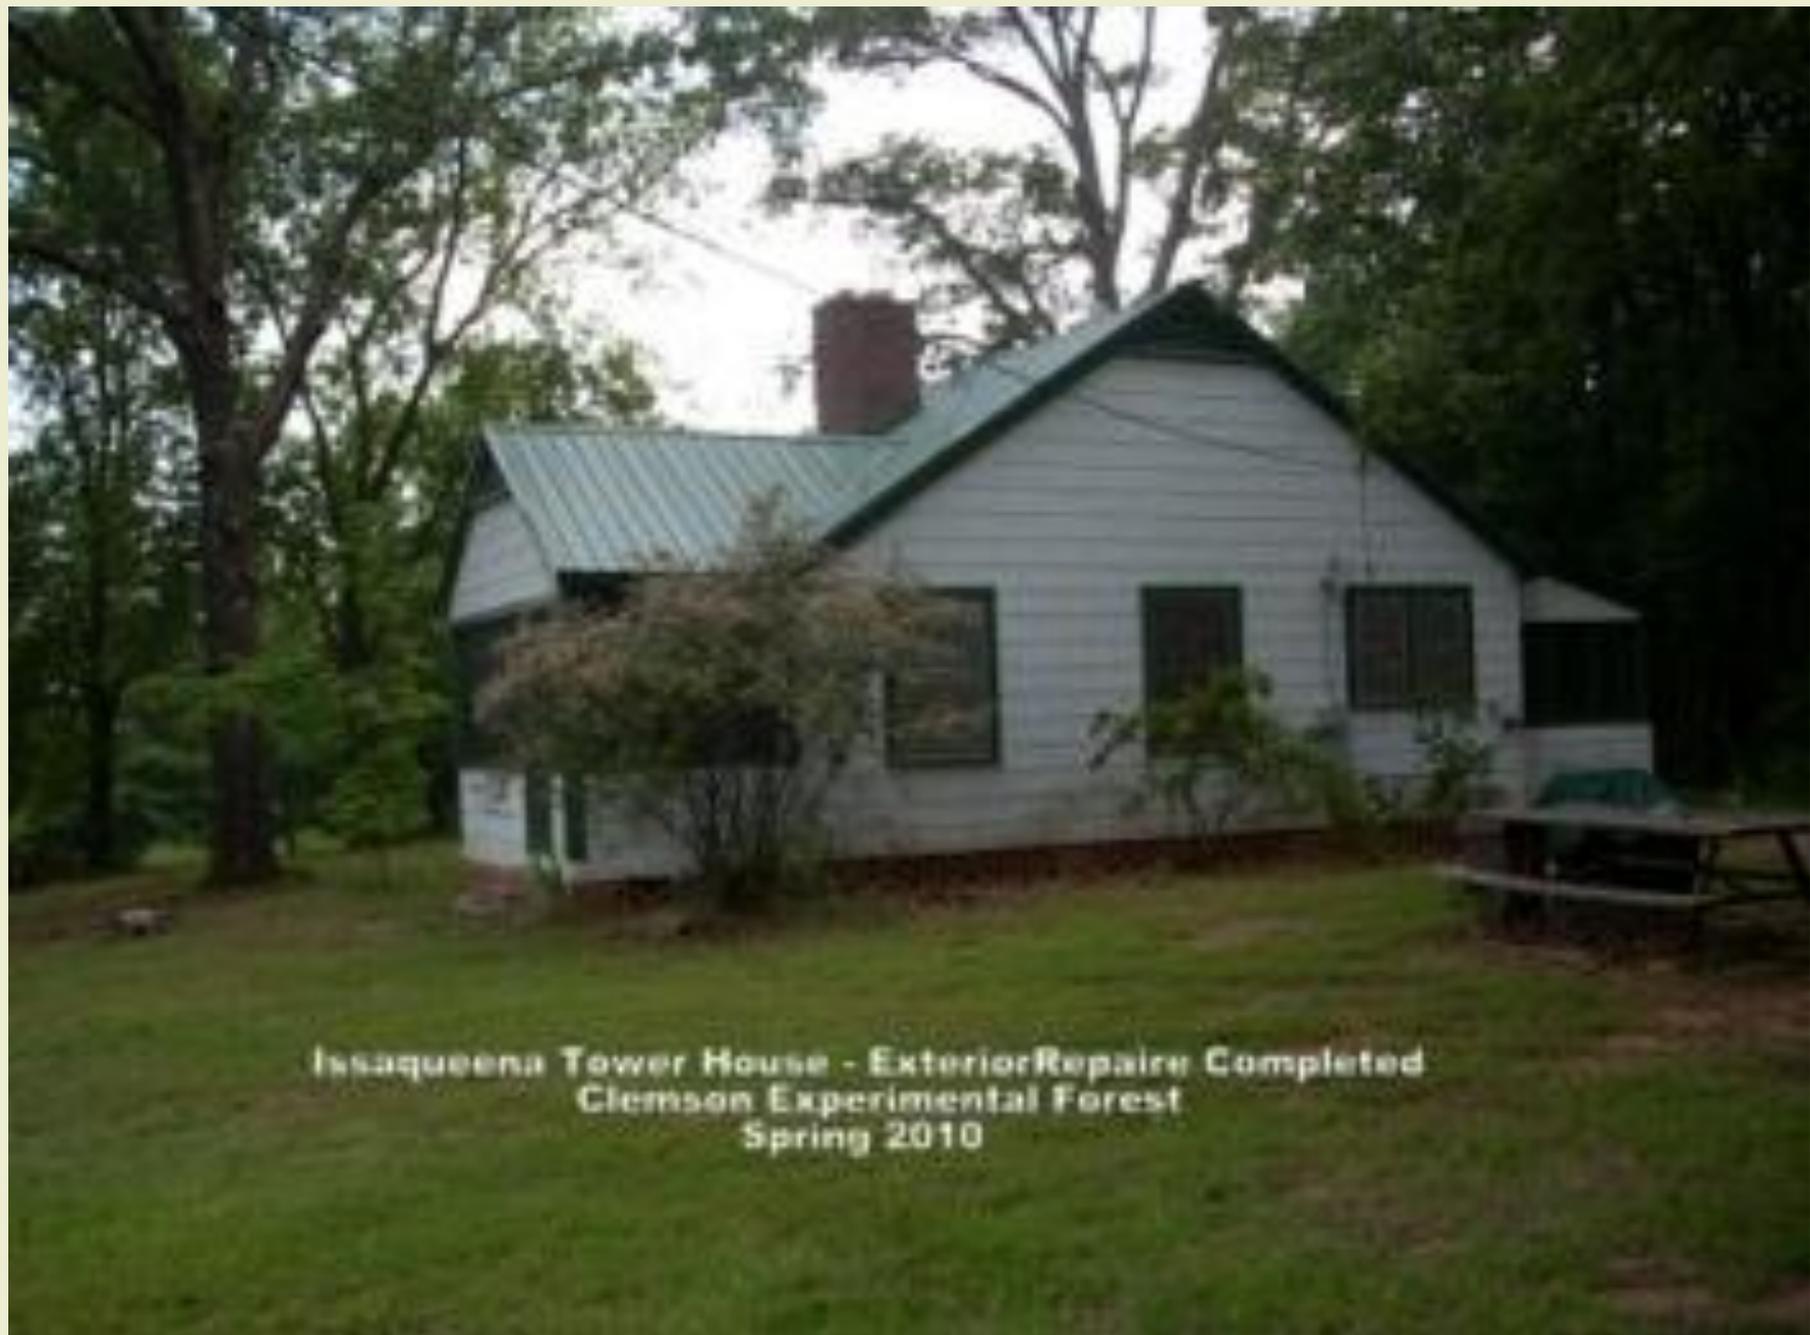
Issaqueena Tower House - Exterior Repairs Completed
Clemson Experimental Forest
Spring 2010

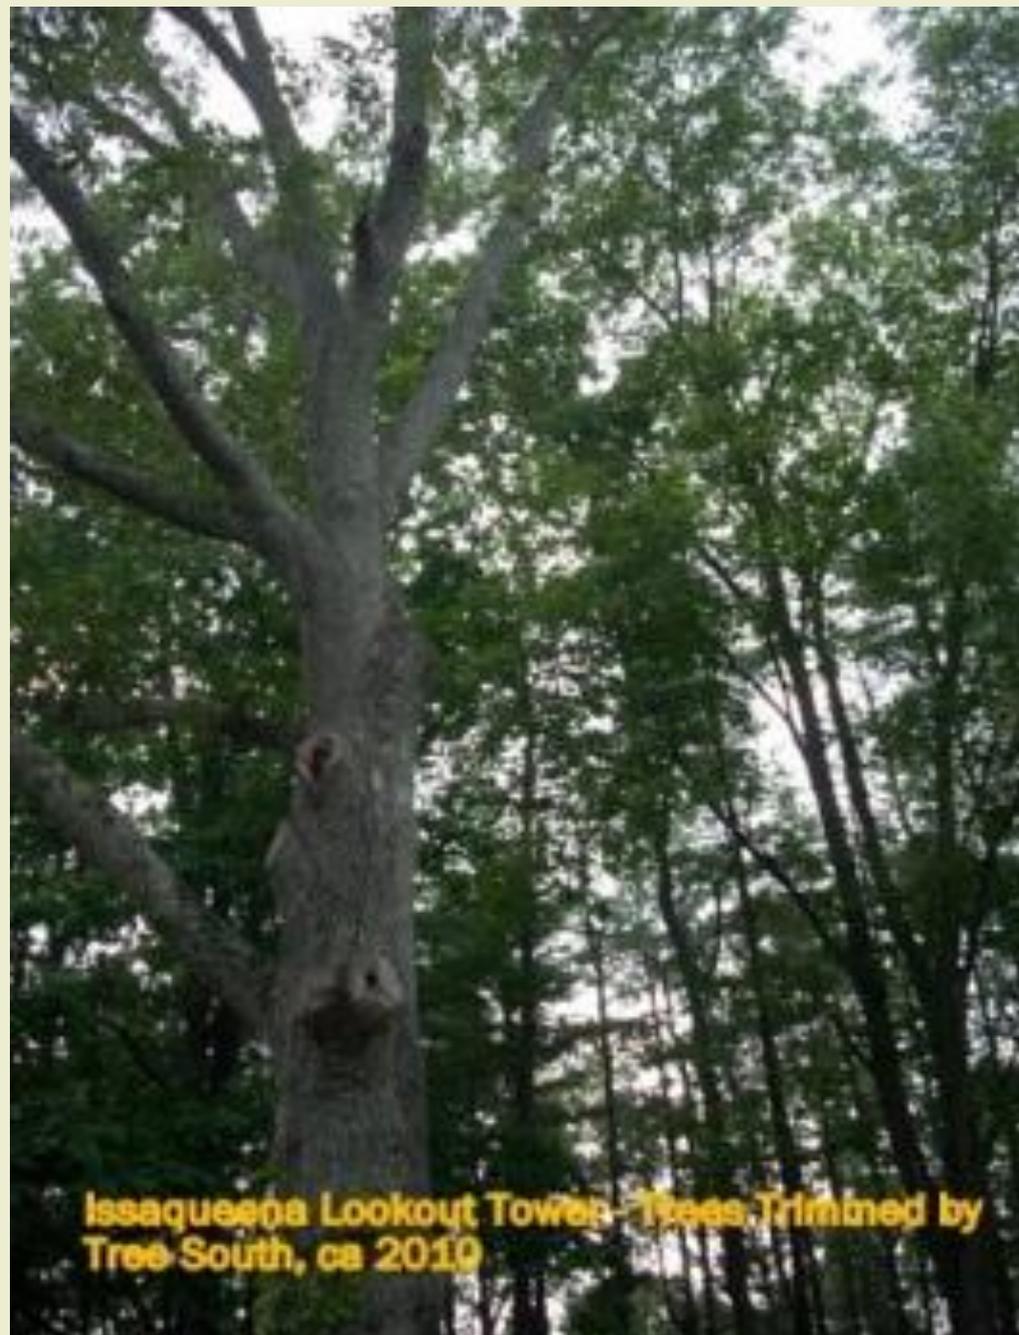
Issaquena Lookout Tower - Trees Trimmed by
Tree South, ca 2019

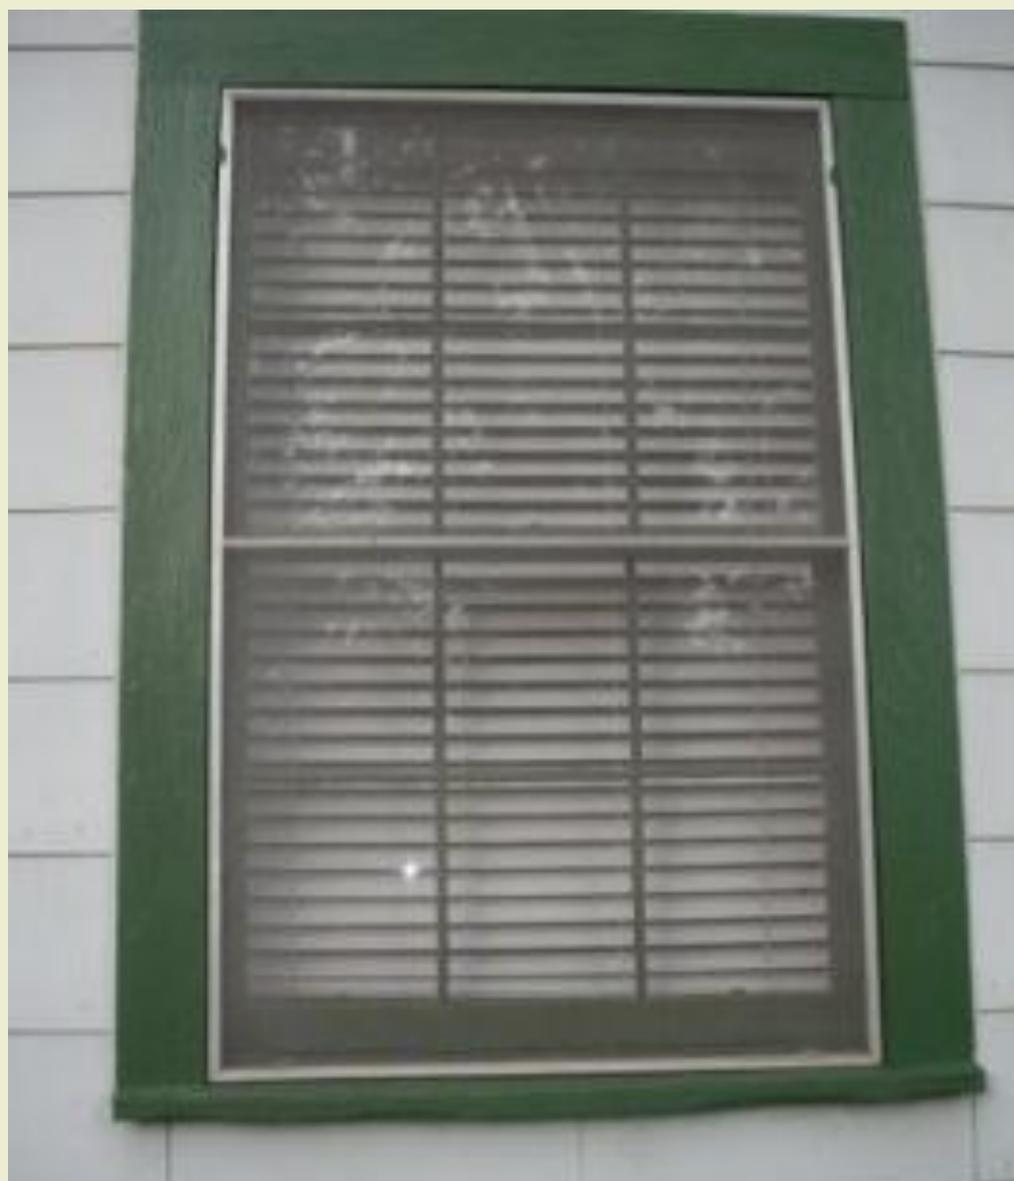
Isaquesena Lookout Tower - windows reglazed and painted. Clemson Exp. Forest, ca 2010

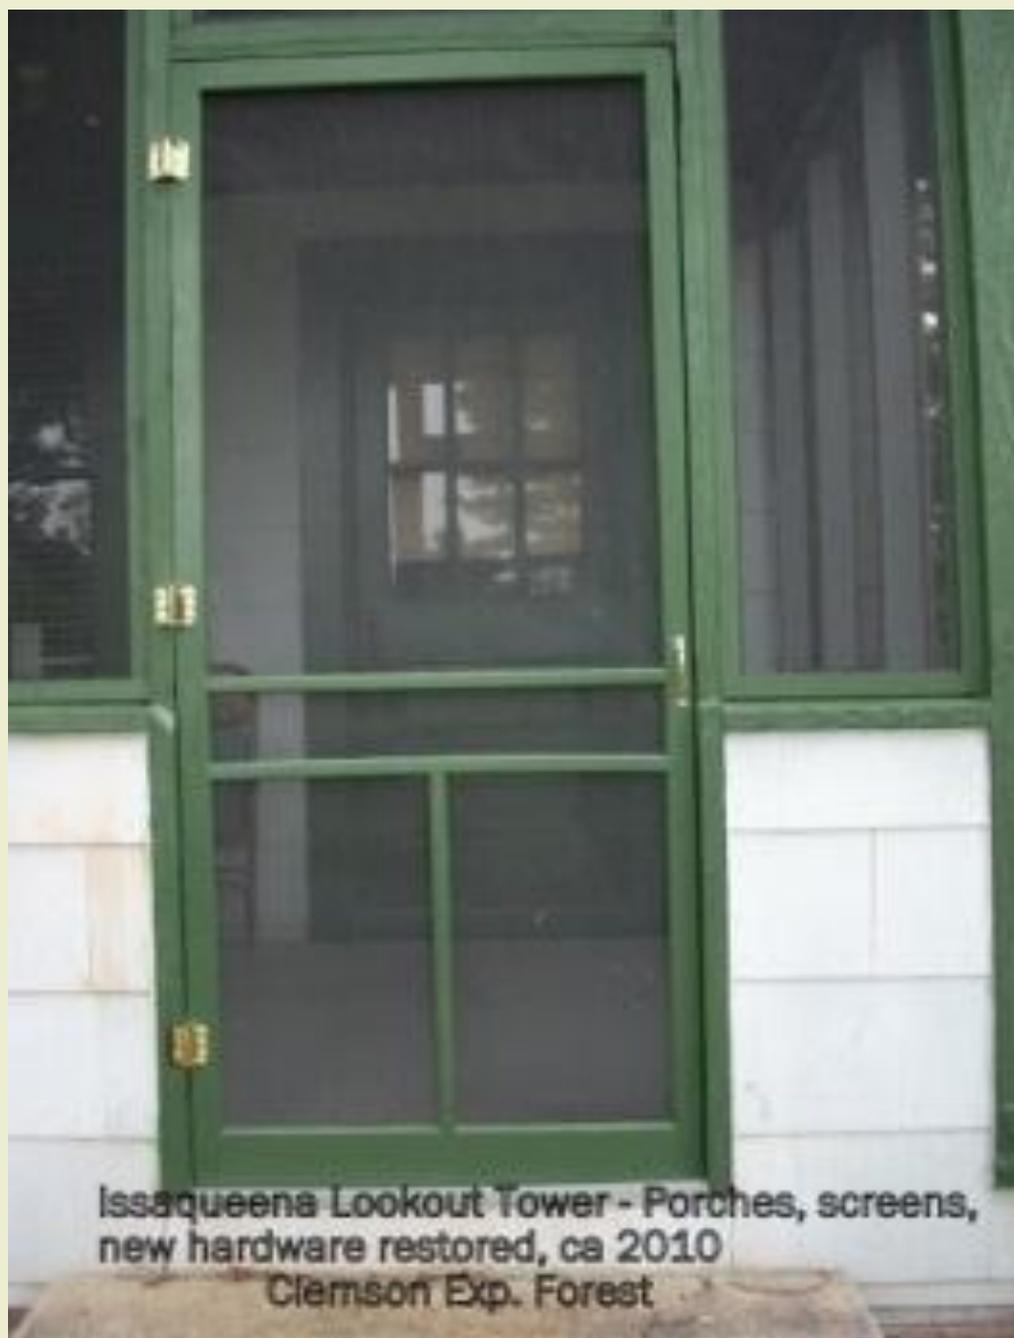
Issaqueena Lookout Tower - Porches, screens,
new hardware restored, ca 2010
Clemson Exp. Forest

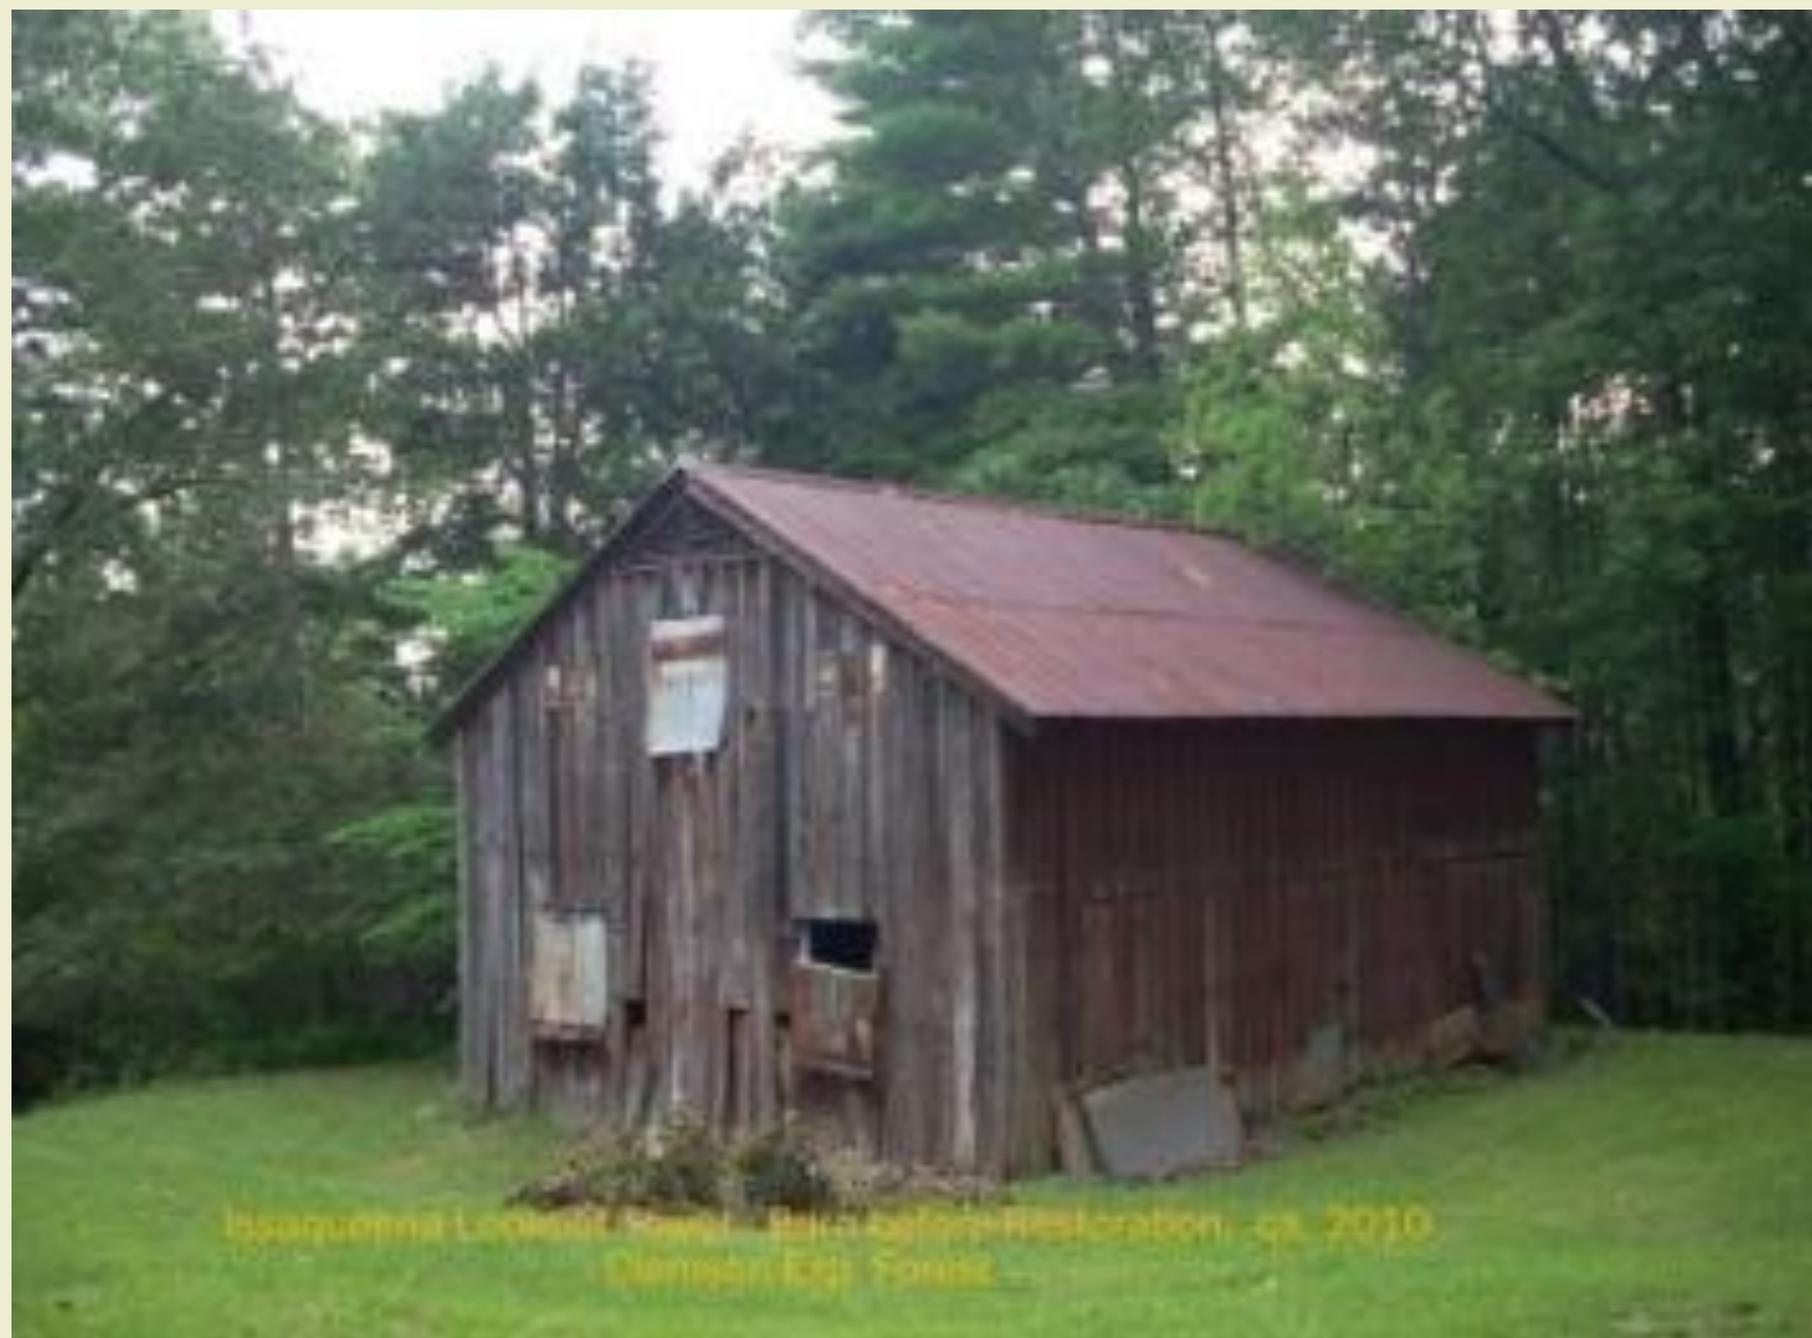
Isaquonnia Lockwell Farm - Barn before Restoration - ca. 2010
©Nancy Egg Forest

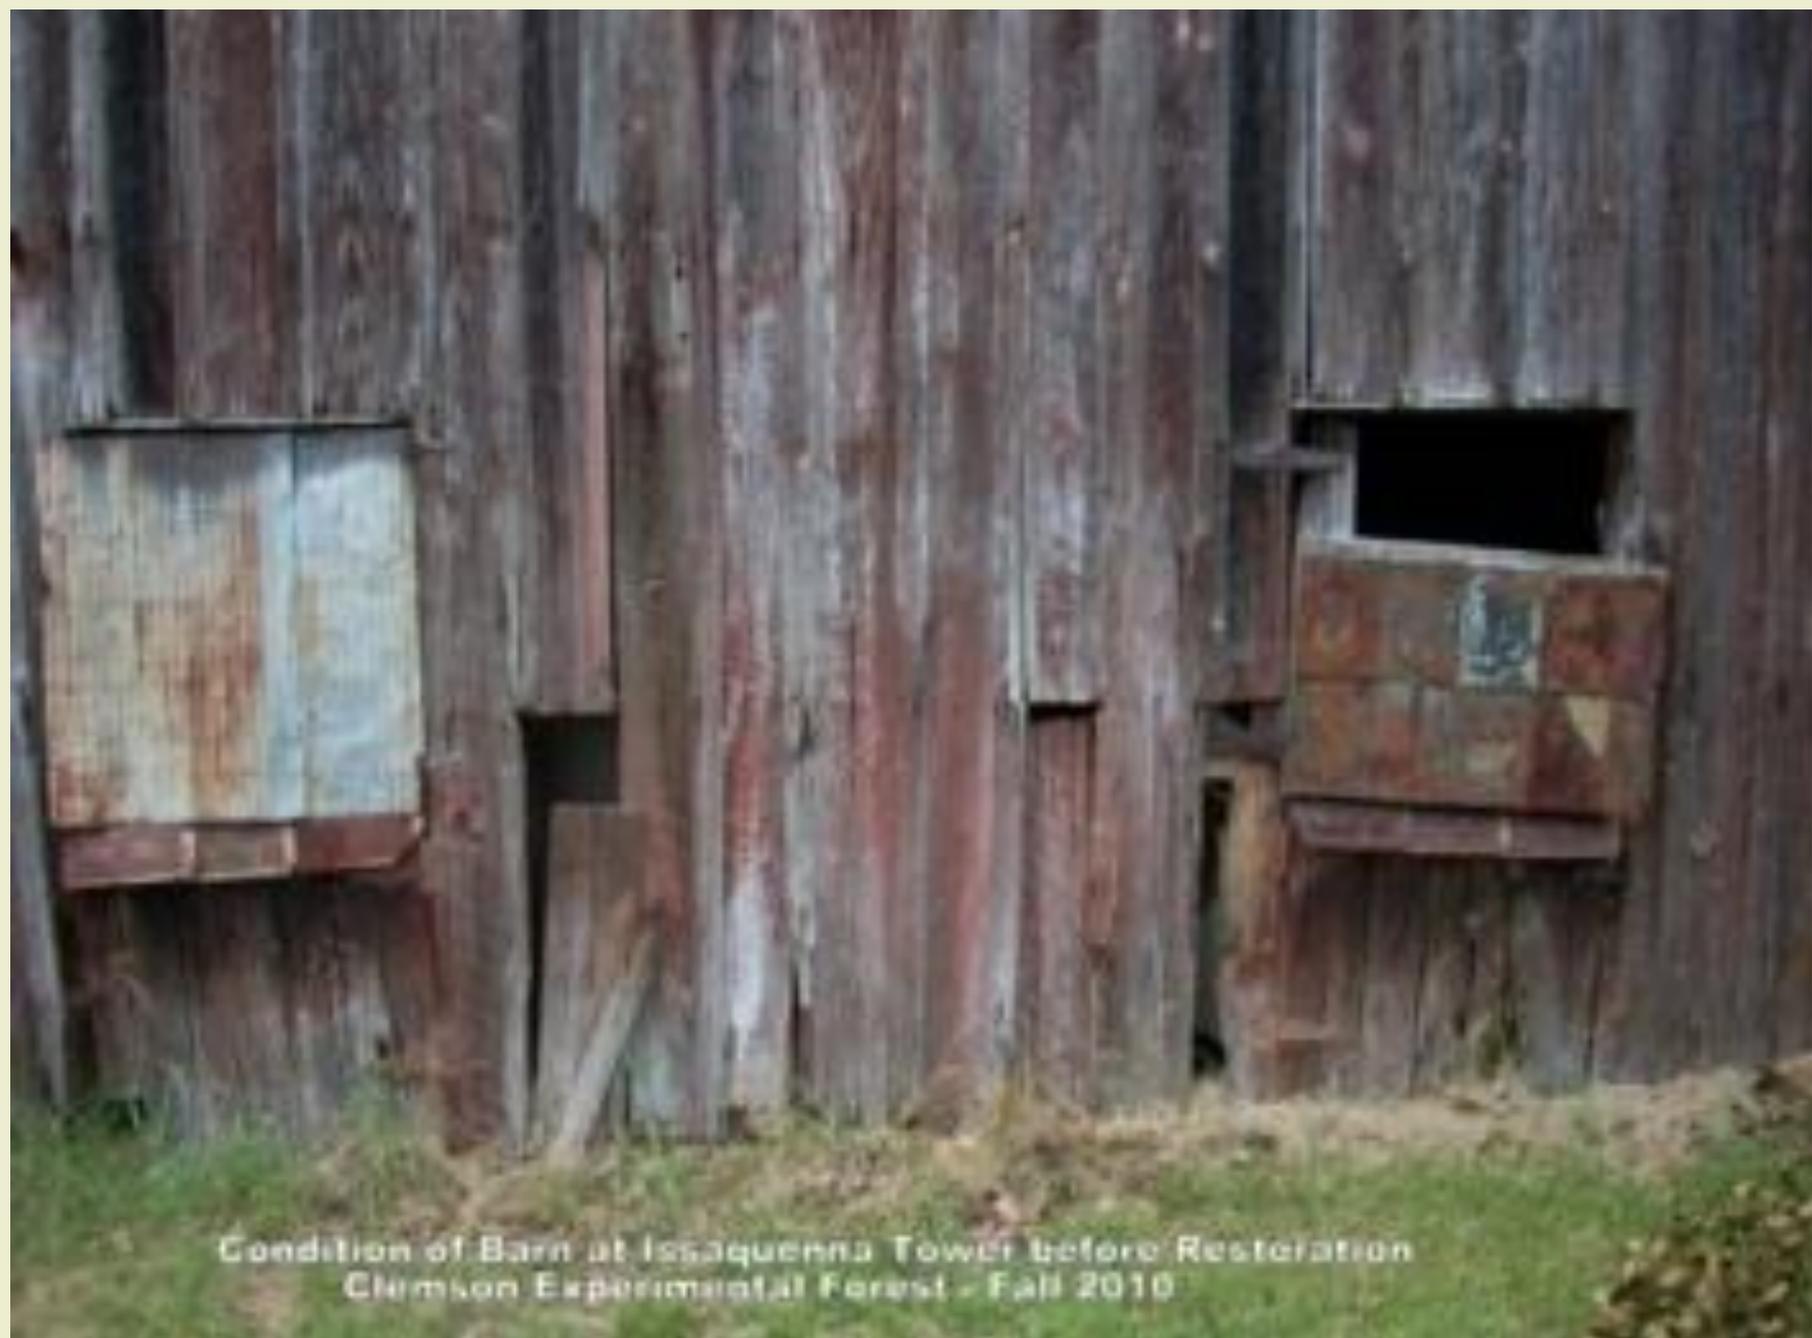
Condition of Barn at Issaquena Tower before Restoration
Clemson Experimental Forest - Fall 2010

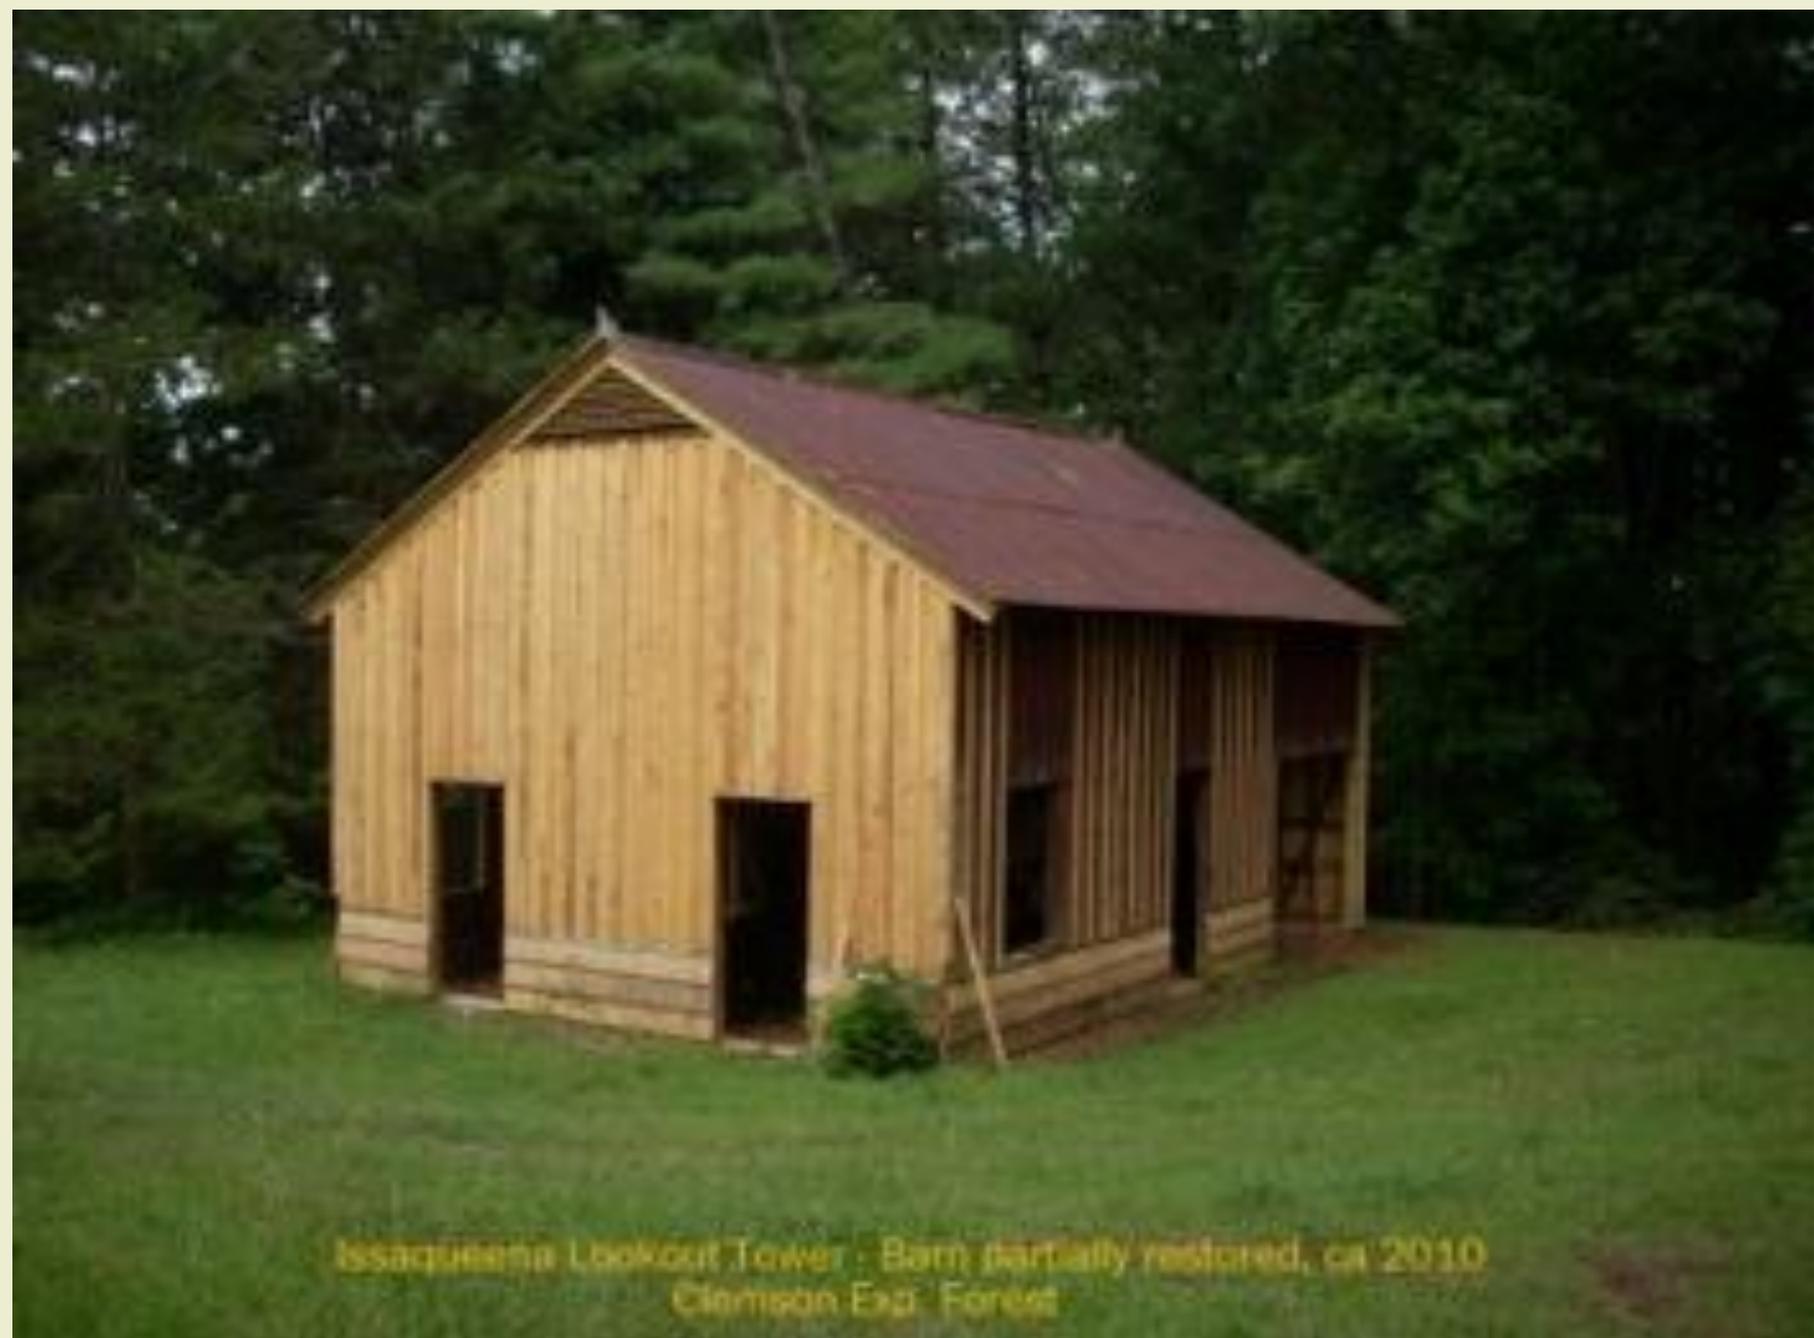
Issaquena Lookout Tower - Barn partially restored, ca 2010
Clamson Exp. Forest

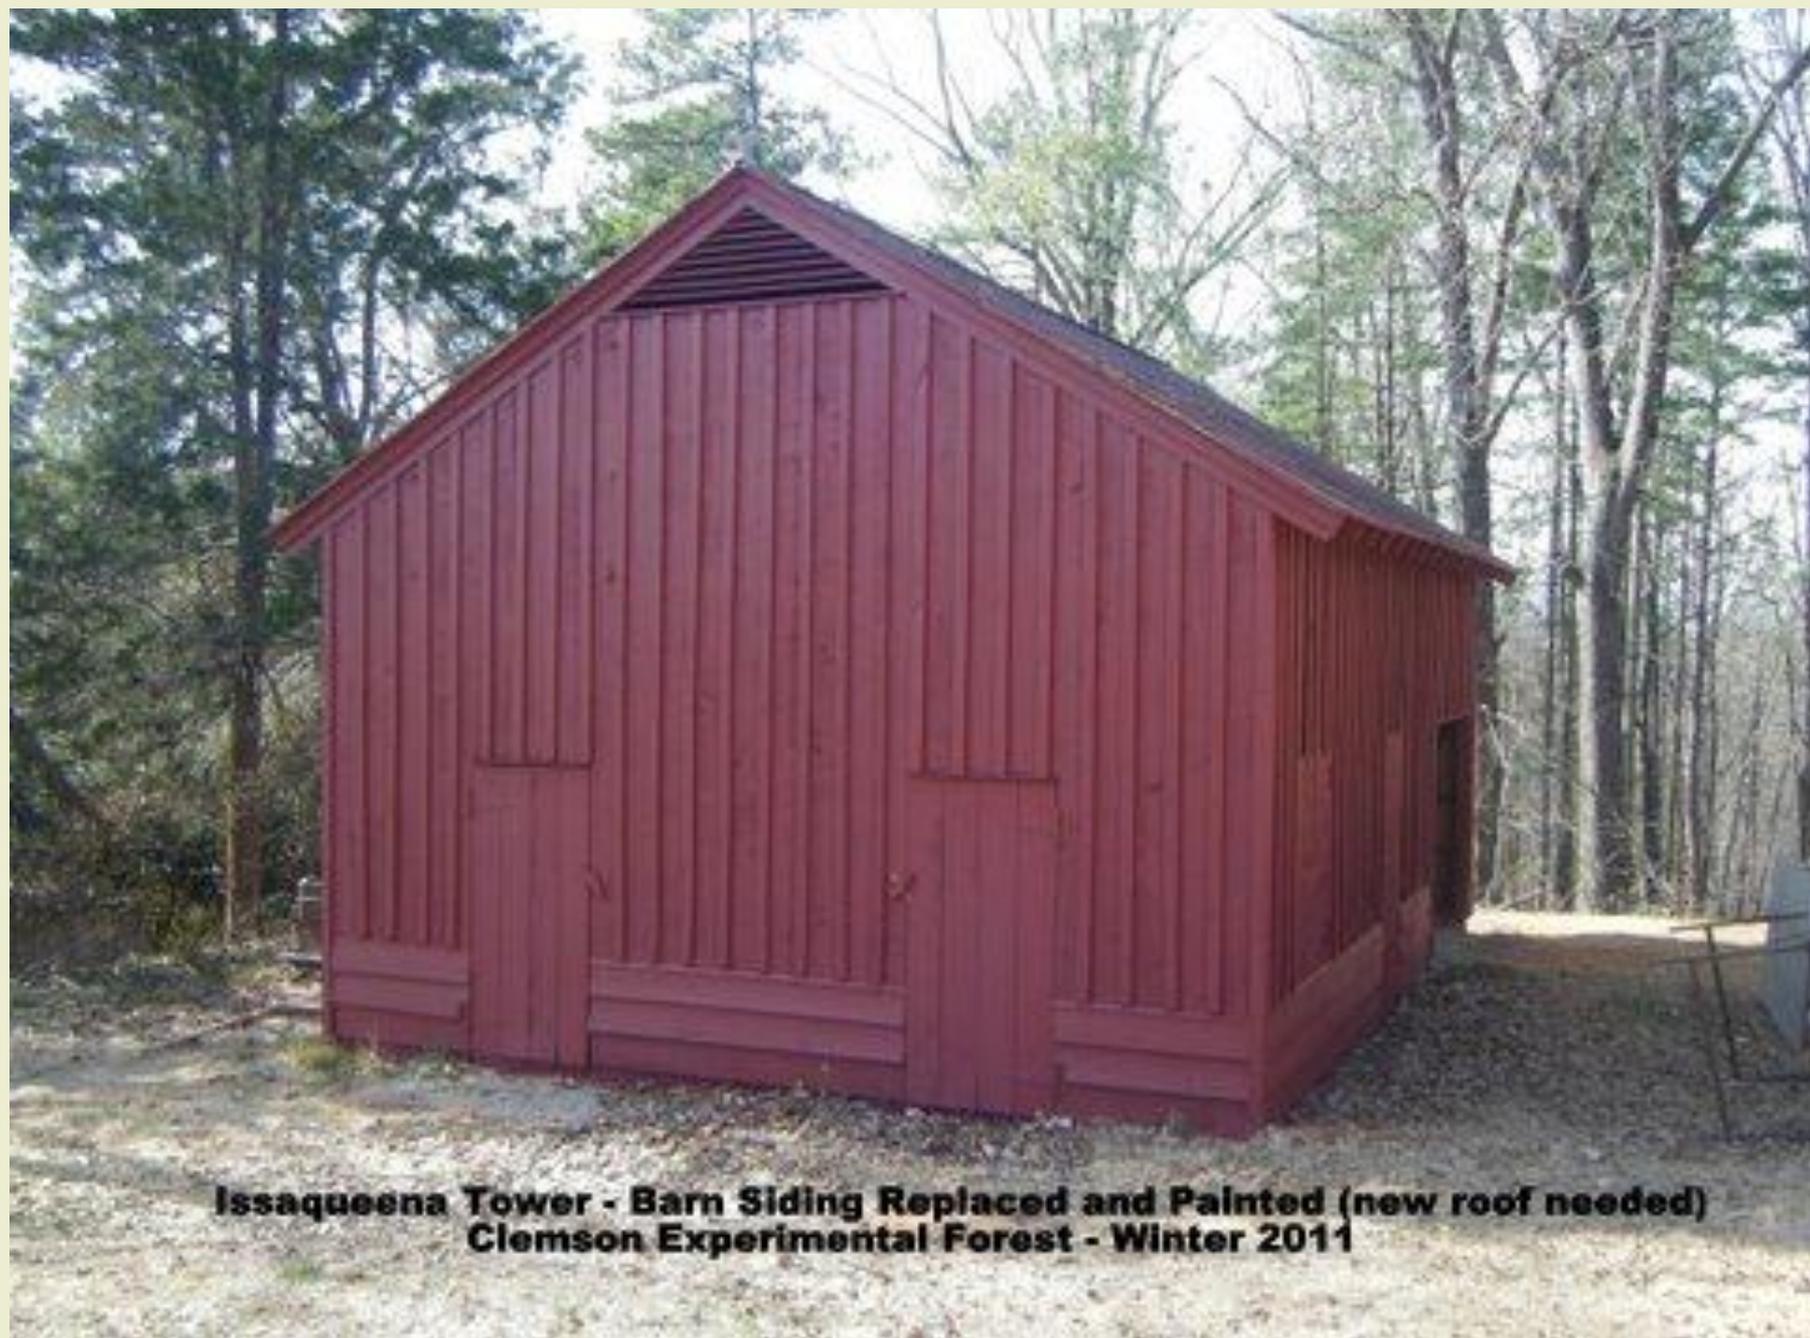
**Issaqueena Tower - Barn Siding Replaced and Painted (new roof needed)
Clemson Experimental Forest - Winter 2011**

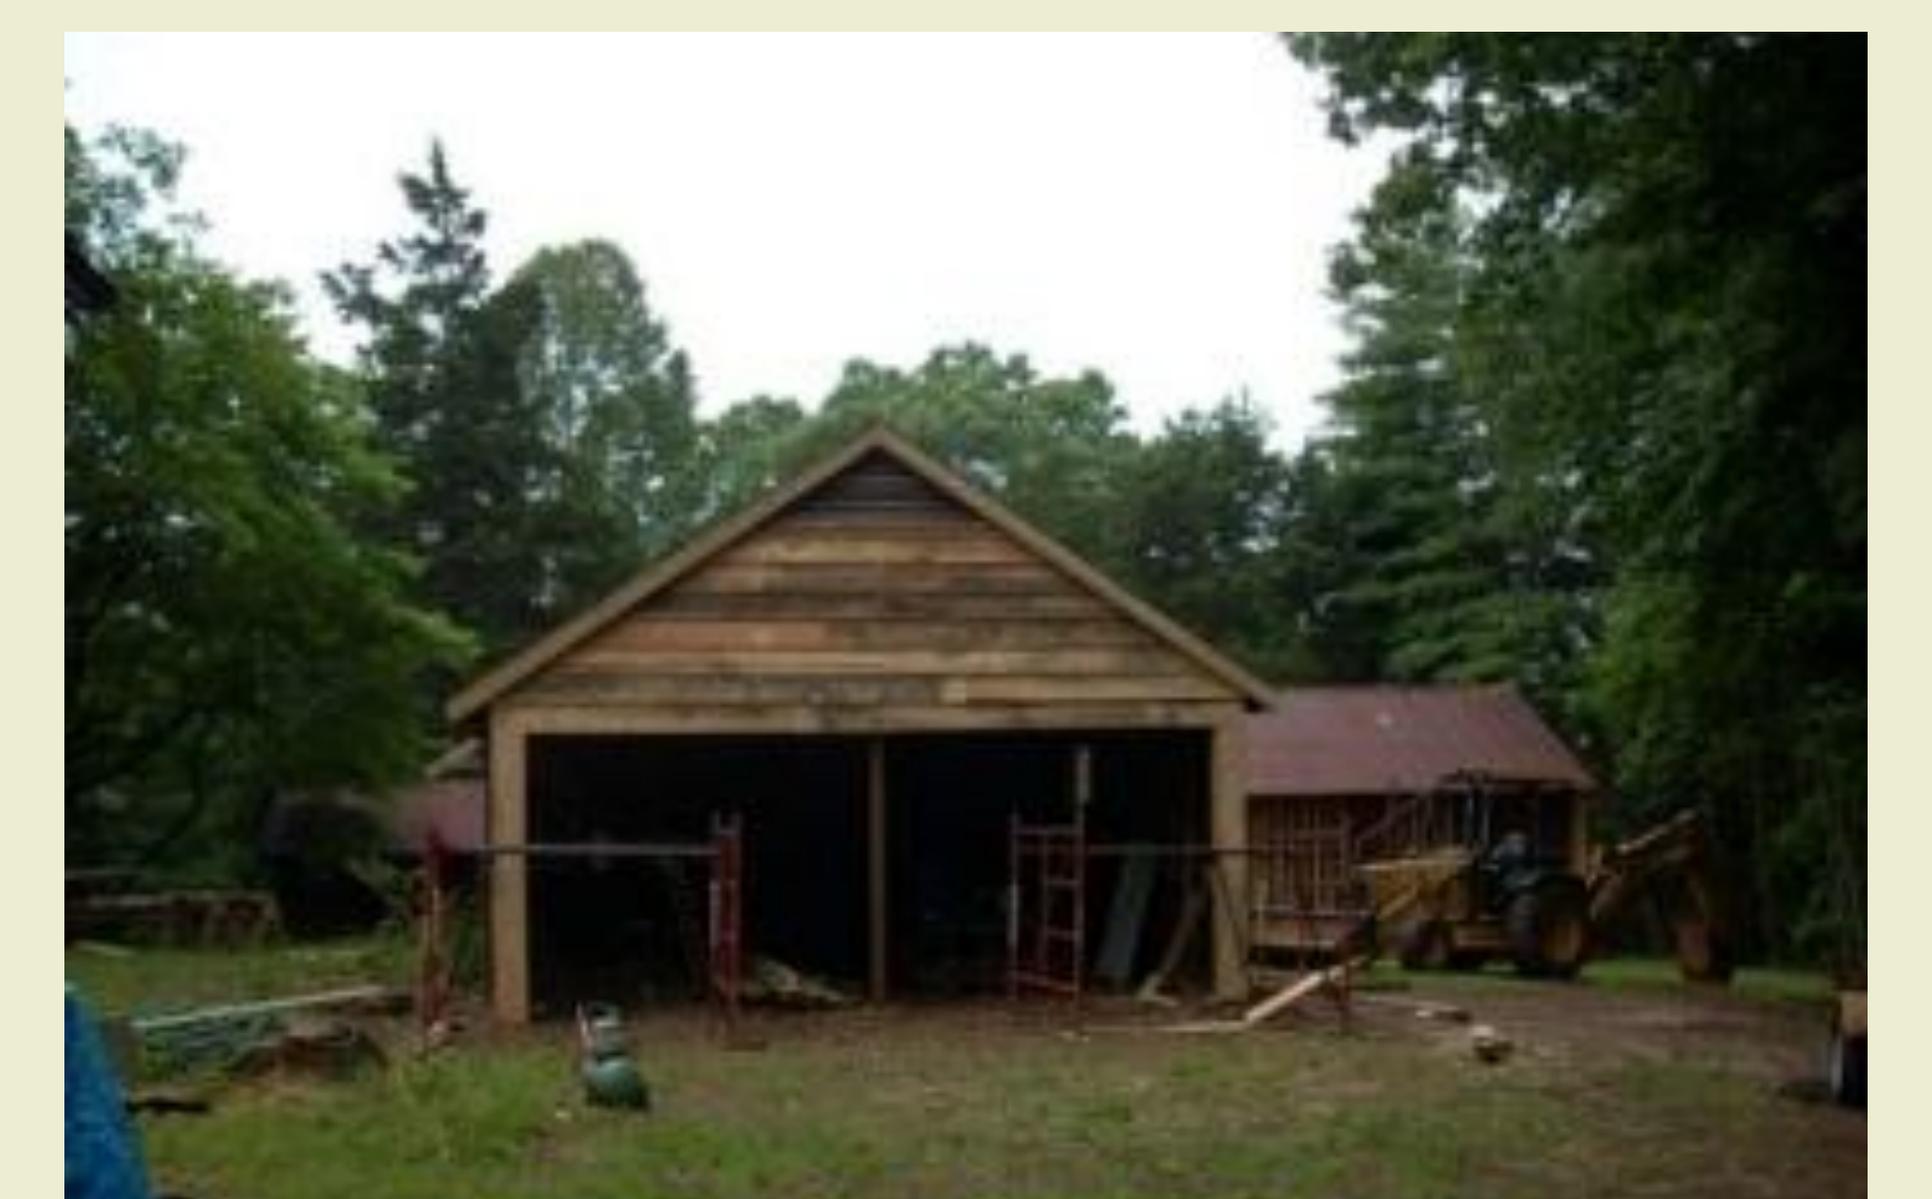
Inaquesna Lookout Tower - Garage restoration, ca 2010
Clemson Exp. Forest
