ISSAQUEENA LOOKOUT TOWER – RESTORATION COMMITTEE REPORT

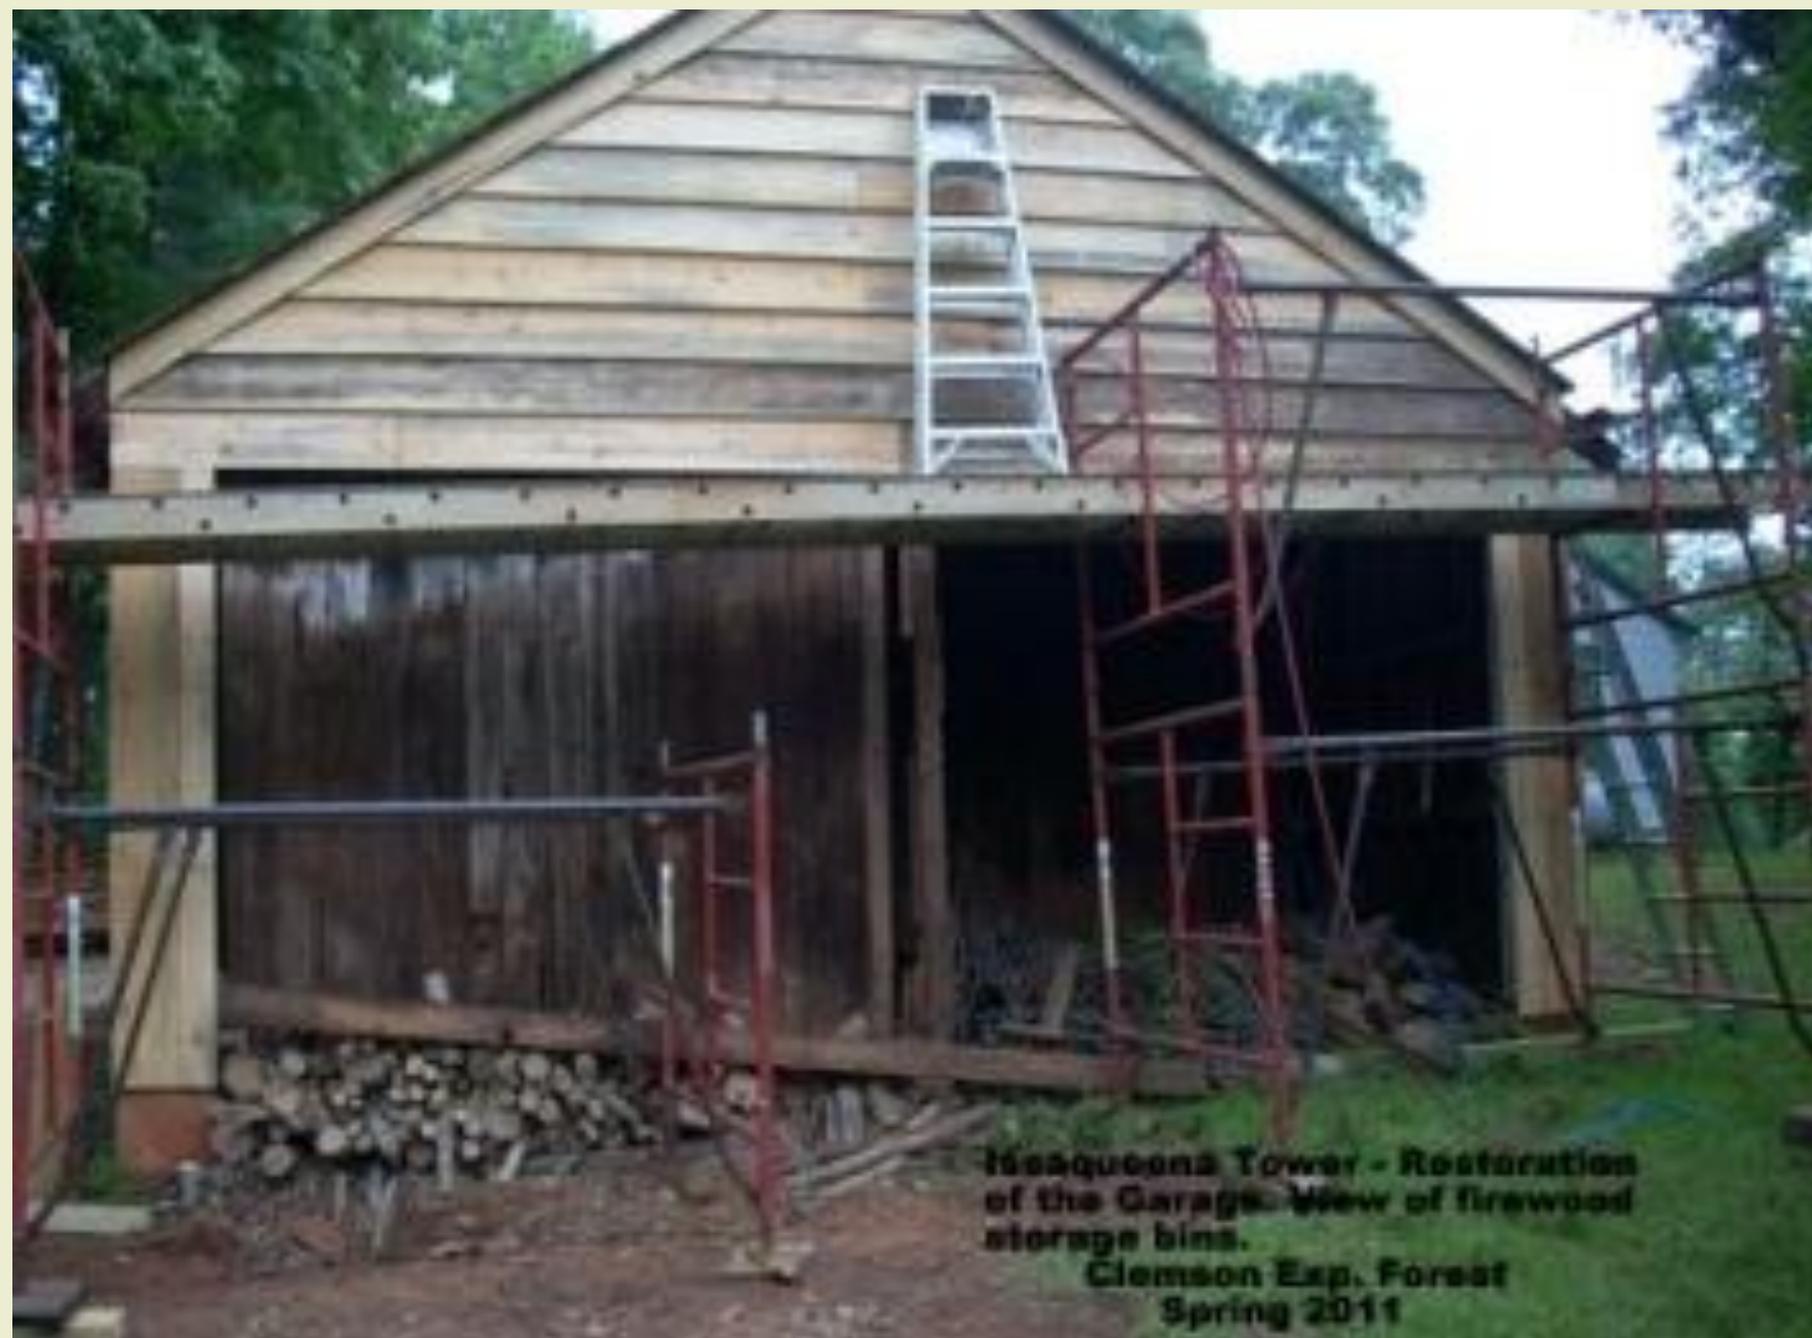
**Issaqueena Tower - Restoration
of the Garage - View of firewood
storage bins.
Clemson Exp. Forest
Spring 2011**

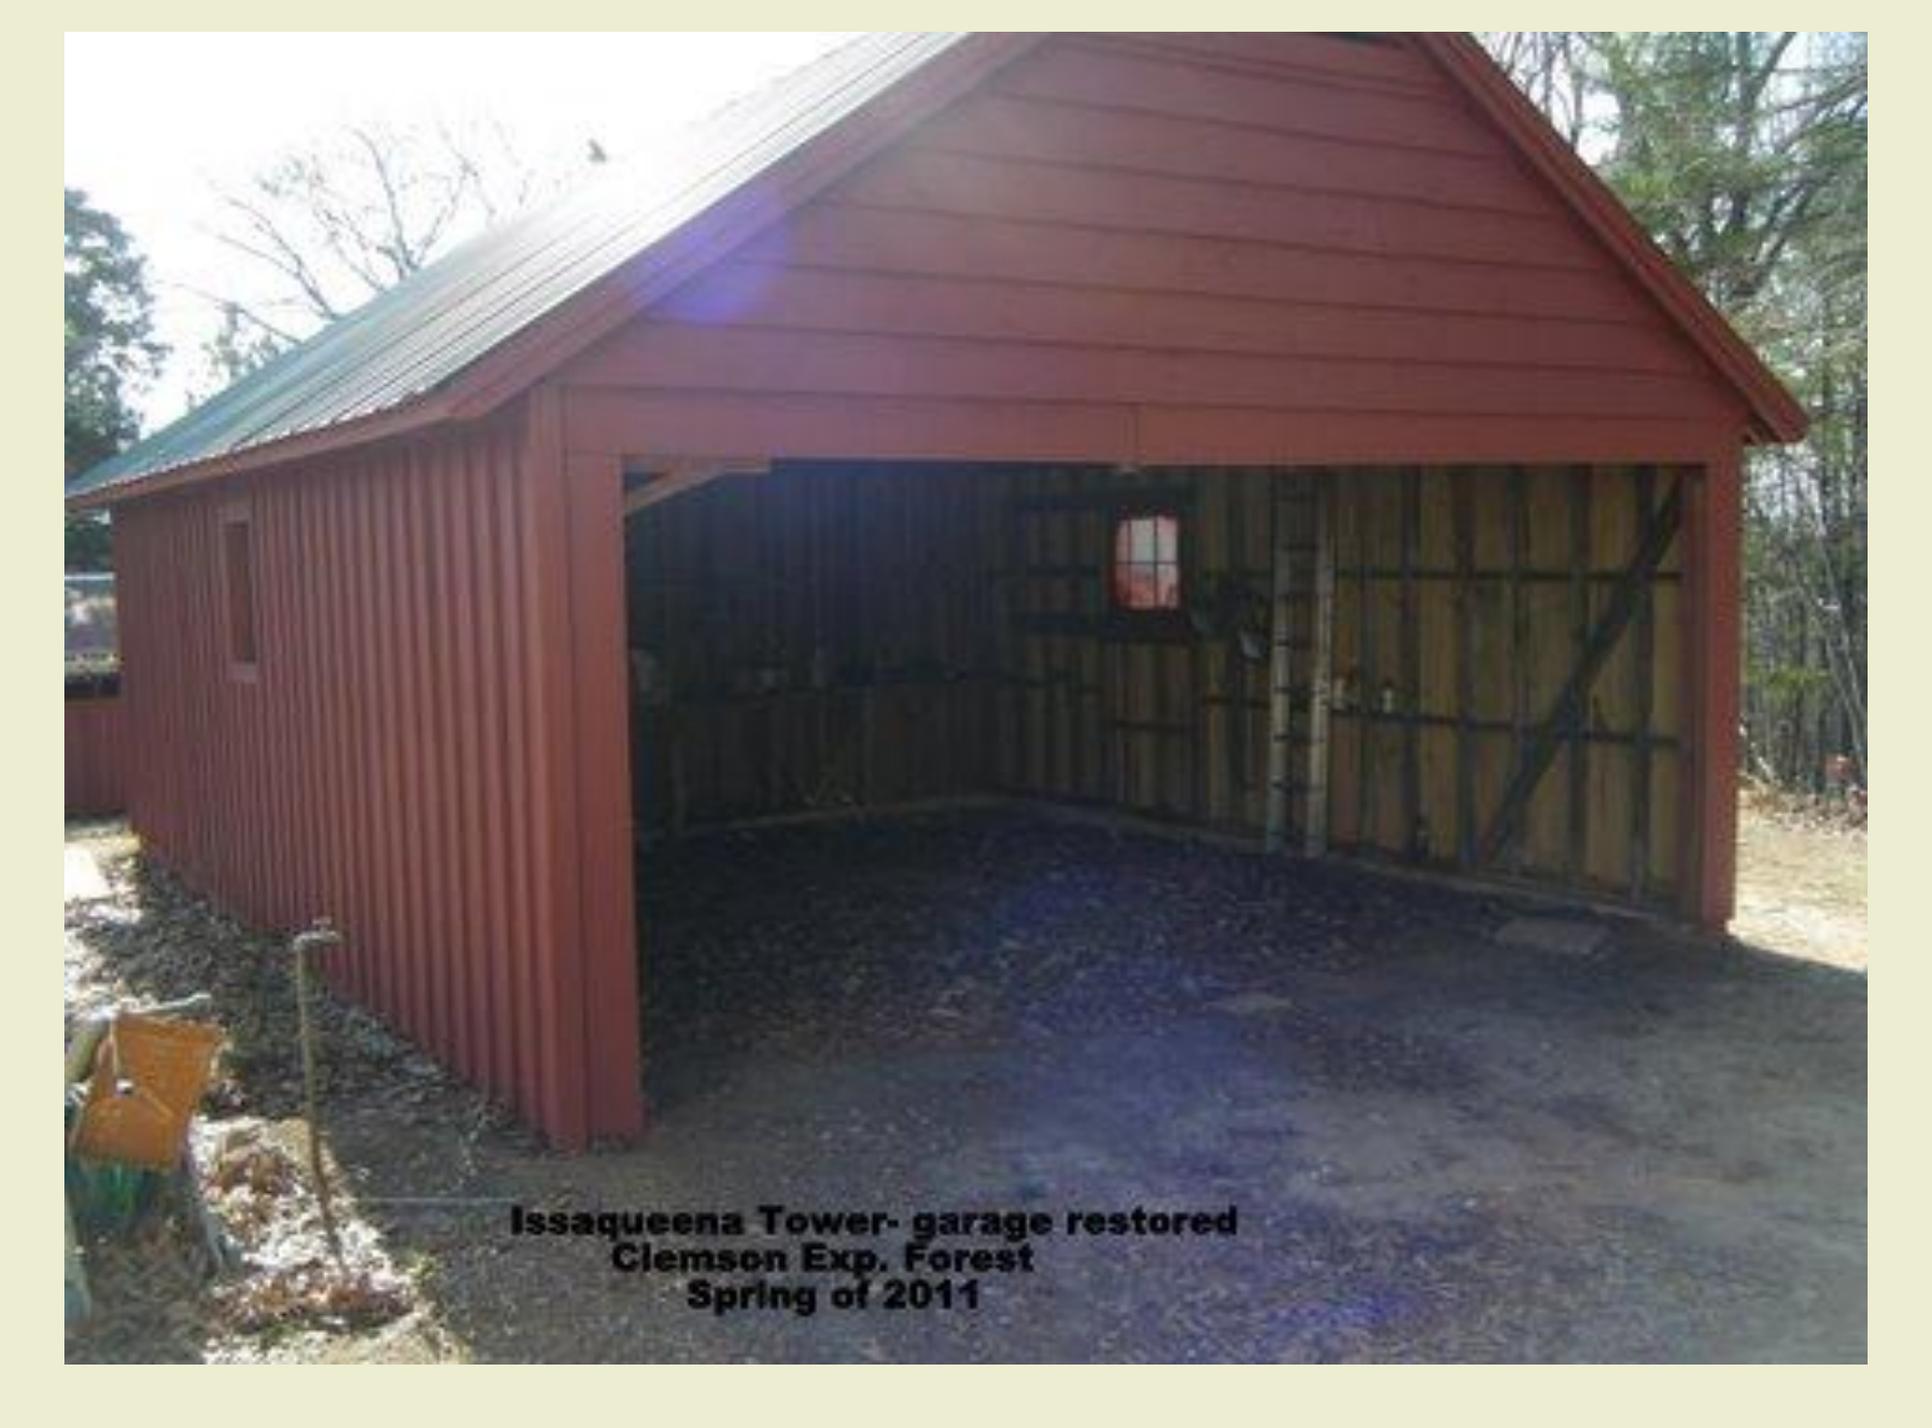
**Issaqueena Tower- garage restored
Clemson Exp. Forest
Spring of 2011**

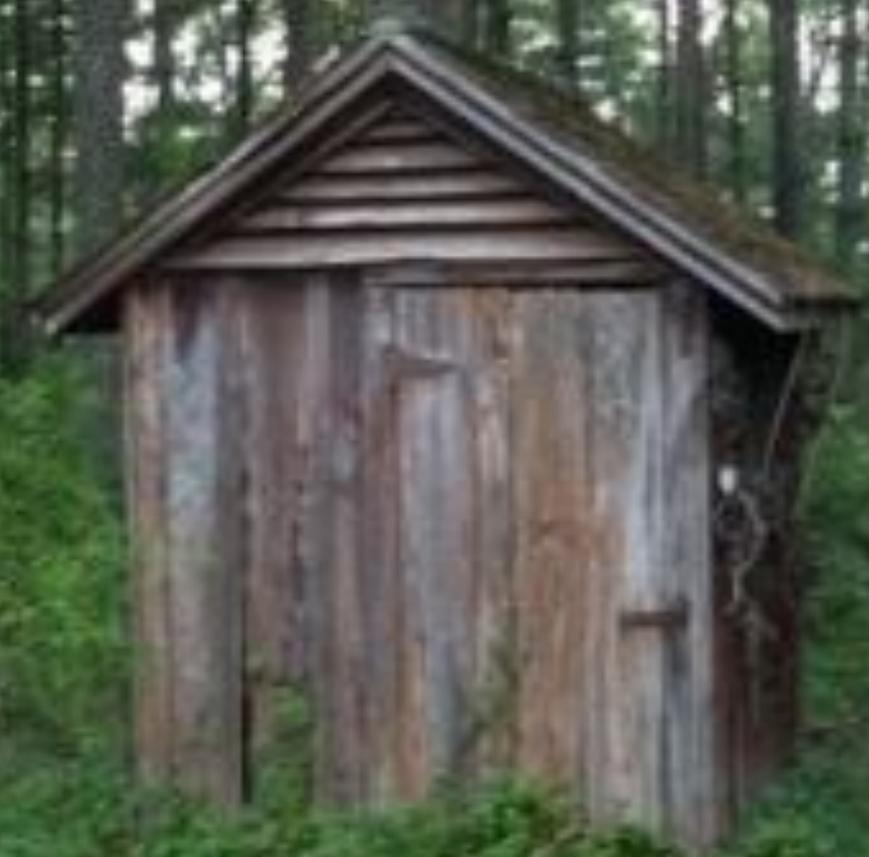
1347
Bisquitona Tower - Smoke House
Clemson Exp. Forest - Summer 1911

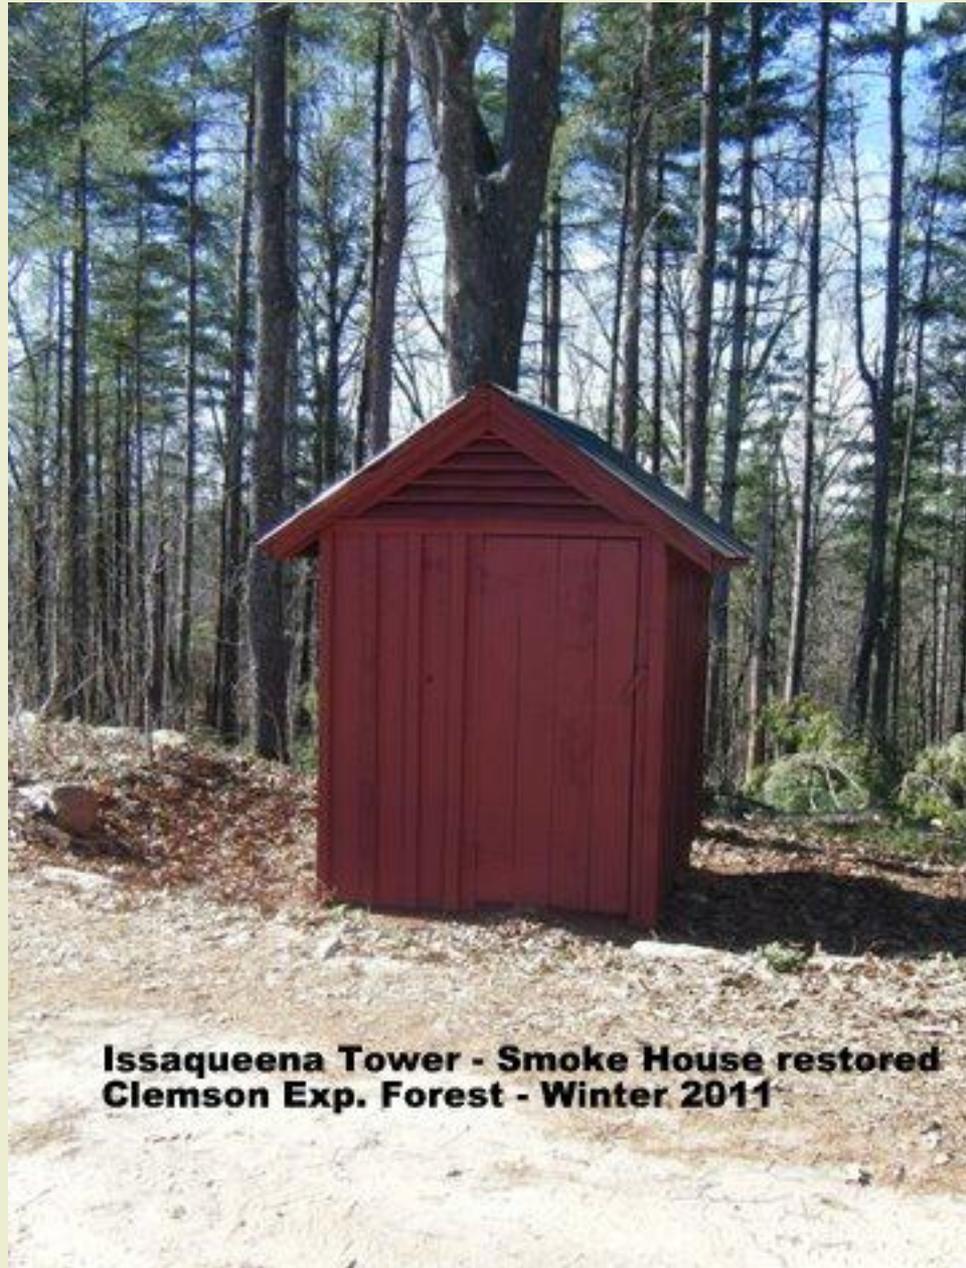
**Issaqueena Tower - Smoke House restored
Clemson Exp. Forest - Winter 2011**
