EVALUATION OF ALUMINIDE COATINGS ON DISCOLORED TURBINE PARTS

Anastasia Taylor

Solar Turbines, Inc.

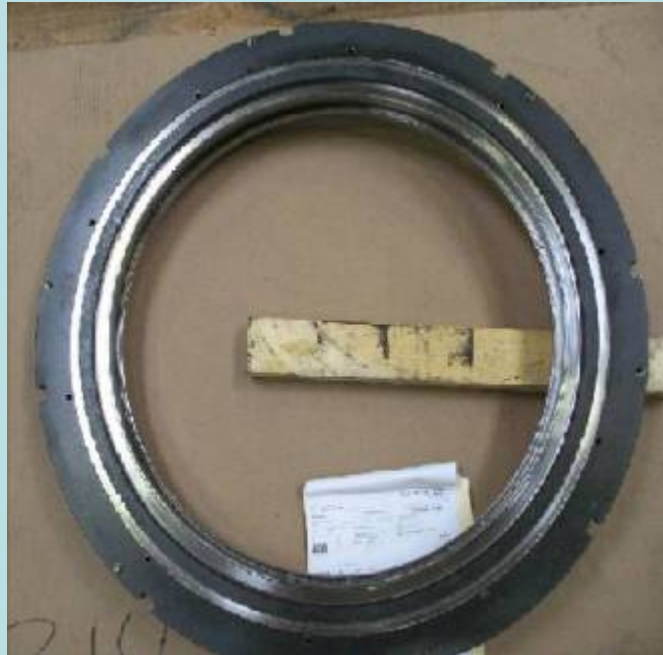
- Black discoloration was first discovered
 - Semi-finished Nozzle Support Rings
 - Taurus 70
 - Titan 130

Semi-finished nozzle support ring

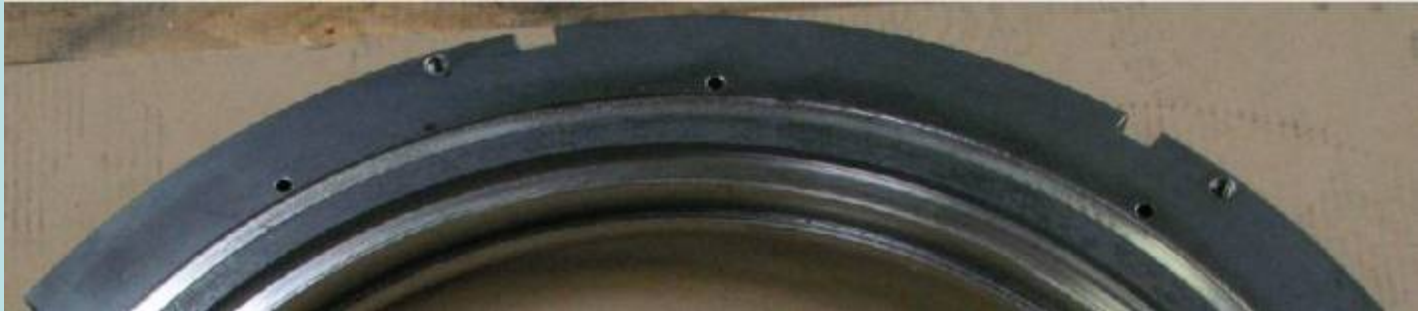
- Parts
 - Made from IN903
 - Coated with a simple aluminide coating
- Discoloration
 - Difficult to remove prior to coating
 - Believed to affect adhesion of the simple aluminide coating

Discoloration of Semi-finished nozzle support ring

- But the discoloration on the nozzle support rings could not completely be removed by standard grit-blasting
- The discoloration on the nozzle case is believed to be a different oxidation from the original support rings

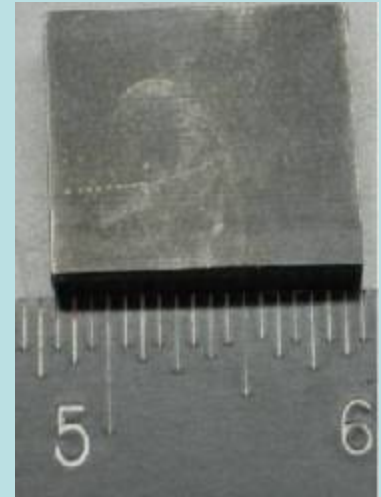
- No nozzle support ring available
 - Destructive testing
- Semi-finished Mars nozzle case
 - Made of 903 Alloy
 - Without an aluminide coating
 - Observed to have the discoloration
- Section of the nozzle case
 - cut into one inch squares for testing

Square test sample

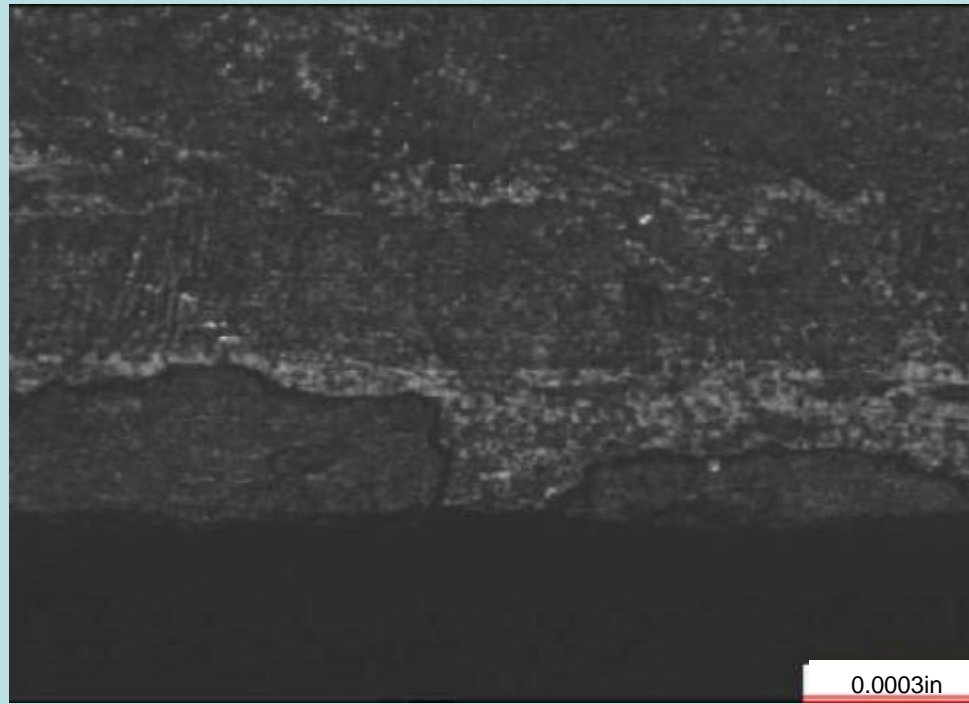
200X magnitude of Mars nozzle case discoloration

- Mars nozzle case
 - Thickness
 - Taken nondestructively by magnetic induction
 - Chemical composition of the discoloration
 - Scanning Electron Microscope (SEM)

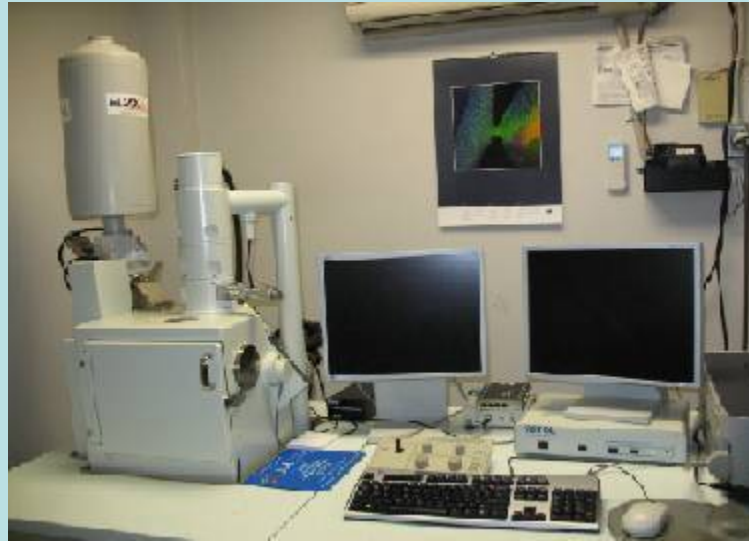
Scanning Electron Microscope

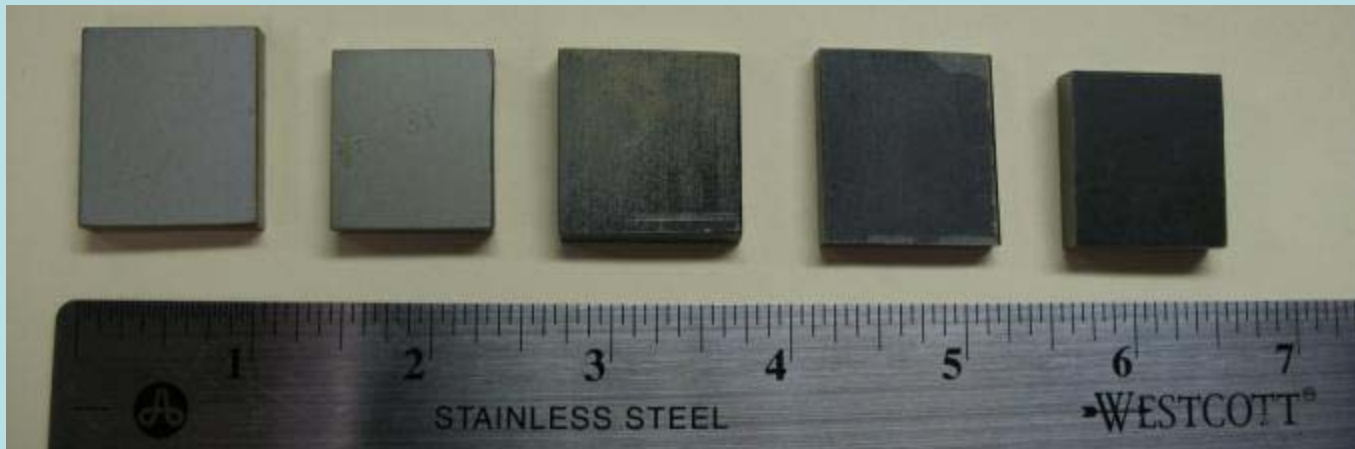
- Supplier was able to completely remove discoloration
 - Using standard grit blasting
- Light grit-blasting only removed part of it
 - As it is seen under the aluminide coating
 - On the third and fourth samples
- Last sample was not grit-blasted

Test samples of Mars nozzle case

- Test samples were shipped to a supplier
 - Cleaned
 - Grit-blasting
 - Coated
 - Simple aluminide coating

- Discoloration on the Mars nozzle case was found to not be representative of the original discoloration on the nozzle support ring.
- Discoloration of Titan 130 nozzle support ring is still being analyzed to find composition, microstructure and thickness

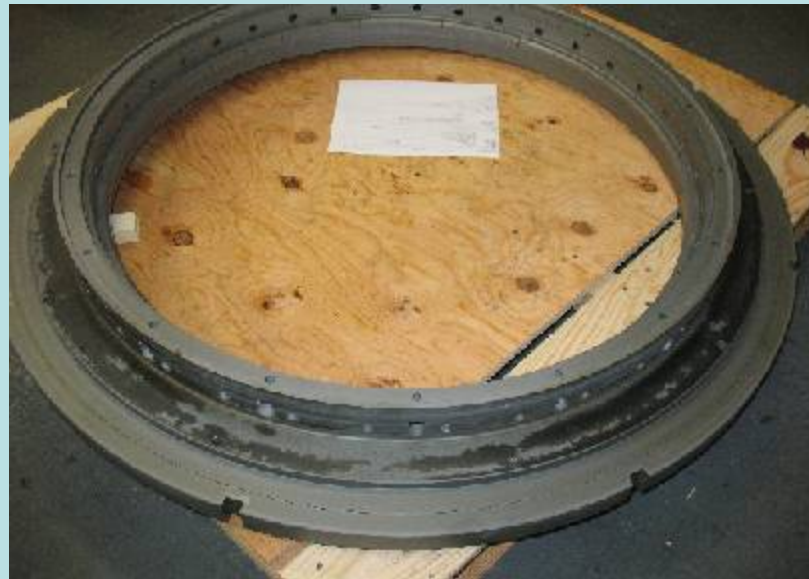
- After the analysis had been completed on the test samples of the nozzle case, a Titan 130 nozzle support ring with black discoloration under the simple aluminide coating became available for destructive testing

Titan 130 nozzle support ring

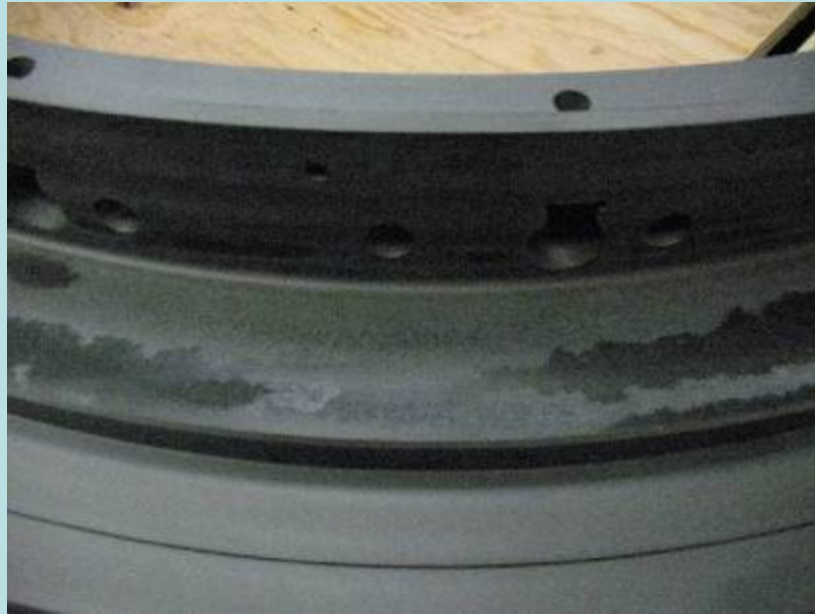
Section of Titan 130 nozzle support ring

- Test coupons
 - Were made of the nozzle ring support
- Some of the samples will be sectioned and mounted to inspect the microstructure and composition of the coating with the discoloration beneath it
