2008 UTSR Industrial Fellowship Program

Final Report

**Anastasia Taylor
Graduate Student
Embry-Riddle Aeronautical University
Daytona Beach, FL 32114**

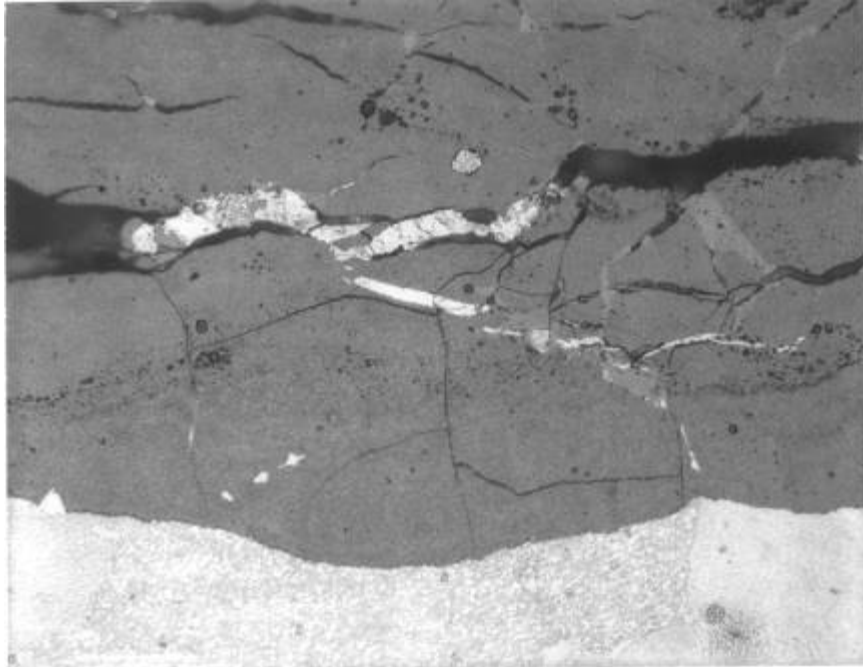
Figure 1: The microstructure of Type II hot corrosion attack

Hot Corrosion typically occurs at elevated temperatures between 550°C and 925°C. Type II Hot Corrosion happens on the lower end of the temperature range up to 750°C. It is caused by the combination of salt and sulfur forming a compound with a low melt temperature. The salt forms an eutectic mixture with a melting point significantly lower than that of the individual constituents [Bose].

The specimens in the study were examined in the area under the platform on blades for Type II Hot Corrosion. The samples were taken from harsh environments that showed signs of corrosion under the platform.

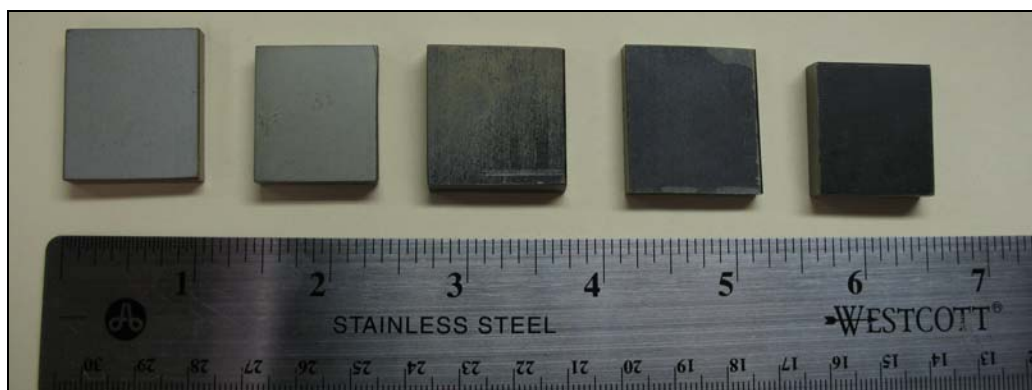
Figure 2: Polished, lightly polished and unpolished samples of a part with black discoloration

Some of the test samples were shipped to a supplier to be cleaned and coated with a simple aluminide coating. Using heavy grit blasting the supplier was able to completely remove the

discoloration. However, light grit-blasting only removed part of the discoloration. That is why the discoloration can be seen under the simple aluminide coating on the third and fourth samples in Figure 2. However, the discoloration on the nozzle support rings could not completely be removed by hard grit-blasting. The discoloration on the nozzle case is believed to be a different oxidation from the original support rings.
