## Watershed-Based Plan

### Georges Creek In The Saluda River Basin, South Carolina

**SUBMITTED BY:**  
Charly McConnell  
Submitted as  
M.S. Final Project Report,  
Clemson University

May 2015

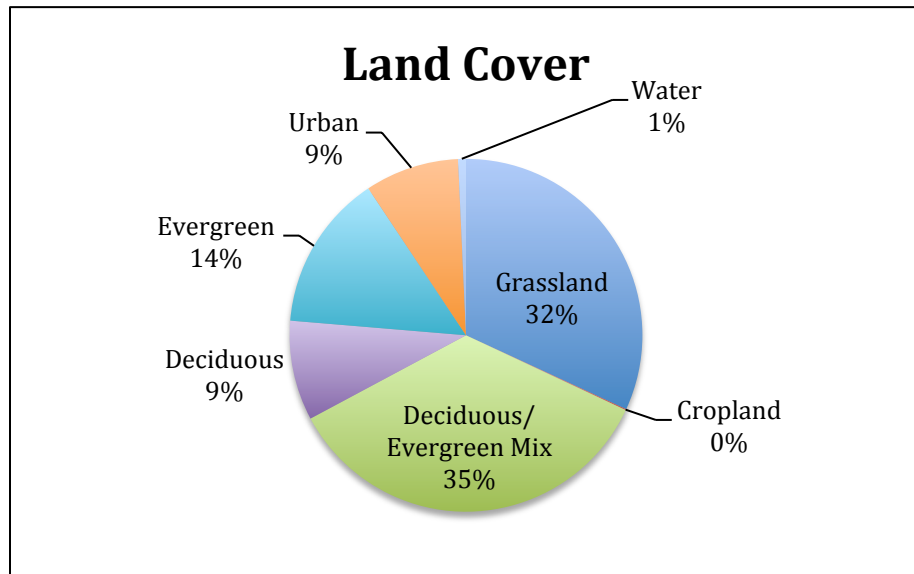
**Figure 3: Overall Land Cover Percentages**

Located within the Piedmont Foothills region of South Carolina, the Georges Creek watershed is composed of a variety of different landscapes. Using data from the Pickens County GIS department, land cover for this watershed was divided into seven categories, as shown in Figure 3. Forested land makes up the majority of the watershed with 58%. Grass or agricultural land makes up the next largest portion of the watershed by 32%. This information shows that

the majority of the Georges Creek watershed is rural with only 9% being developed or urban areas (Figure 4).
